Avoidable Accidents No. 1

# Low-level flying

Research  
AR-2009-041

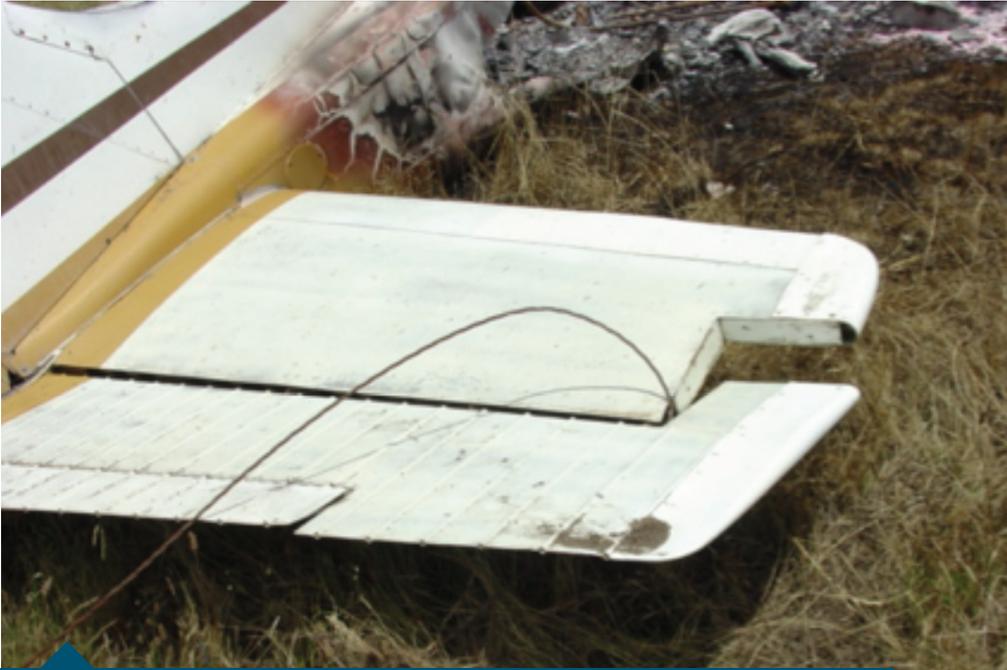
The aircraft had hit powerlines after flying over the house. The powerlines were only 86 ft (26 m) above the ground. Since the pilot was familiar with the area around the property, he was probably aware of the location of the powerlines. However, powerlines are naturally difficult to see. Normal powerlines are not required to be marked for aviation and are usually unmarked, as was the case in this accident.

Section of the struck powerline caught in the horizontal stabiliser

*Just because you know the area and the associated wires, doesn't mean you will always avoid powerlines and other hazards of flying at low level. It only takes a minor distraction to draw your attention from a vigilant lookout. If there is no reason to fly below 500 ft, then don't.*

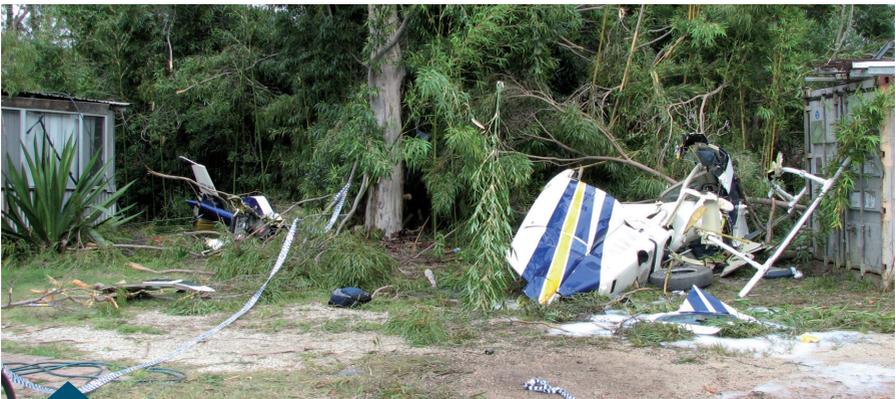
Witnesses reported that the helicopter was making low-level passes, about 100 ft above the ground, over the property. After one of the low passes, the helicopter banked steeply to the left, rolled out and descended. As the helicopter was being operated at a height at which recovery was not possible, it impacted surrounding trees. The helicopter was severely damaged and broke into several parts on impact.

The helicopter had been maintained and inspected appropriately and no mechanical defects were found that would have affected the safe flight of the helicopter. However, it was found that the helicopter was 28 kg over its maximum take-off weight limit (MTOW) at the time of the accident. One of the passengers confirmed they were not weighed prior to departing Bankstown airport.

Wreckage of the Bell Helicopter 206B Jetranger III

*The pilot would have had more time to assess and react to the loss of control situation had he operated the helicopter at the manufacturer's weight limitations and at 500 ft or more above ground level in accordance with civil aviation regulations.*

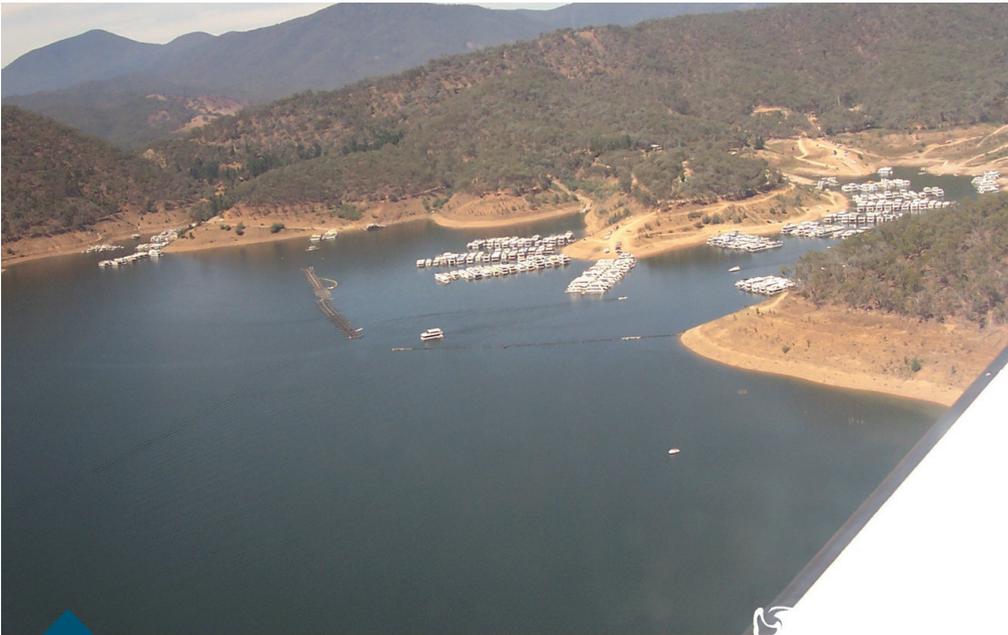
Lake Eildon, Victoria

The Piper PA-28 Cherokee Arrow aircraft struck high-voltage powerlines suspended over the lake. The aircraft was destroyed by the impact with the wire and with the water. All three passengers were fatally injured and the pilot's body could not be found.

The power line involved in the accident spanned a 2 km length across Lake Eildon. The aircraft struck the power cable at the lowest point of the span, which was only 133 ft (40 m) above the water. Under relevant Australian Standards, the power line was not required to be fitted with marker devices as it was less than 295 ft (90 m) in height.

*Do not rely on marker devices to alert you to the presence of powerlines. Powerlines under 295 ft (90 m) in height, as was the case in this accident, are not required under Australian Standards to be fitted with marker devices.*

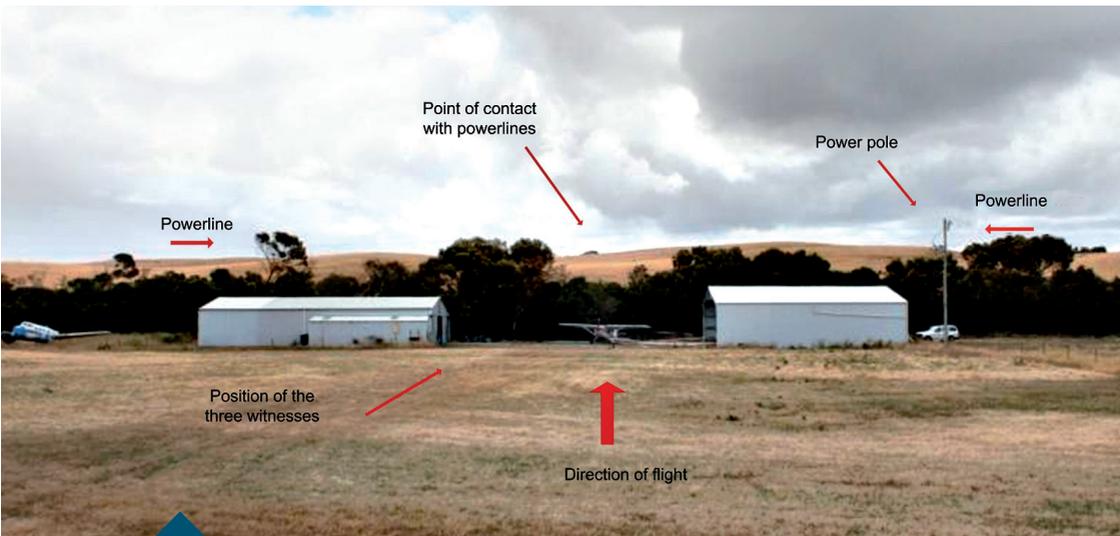
Accident location

As the aircraft approached the hangars, it climbed suddenly and hit powerlines that passed across the gap between the hangars. Investigation of the wreckage found that the aircraft propeller took the full force of the wirestrike, causing the propeller to disintegrate and the engine to stop. The aircraft aerodynamically stalled at a low altitude, possibly due to the pilot's attempt to avoid trees directly behind the powerlines. Due to the pilot's low altitude, he had little margin to recover from the stall, and the aircraft impacted the ground almost vertically. The pilot sustained serious head injuries, and did not survive.

Although the pilot was familiar with the airstrip and was aware of the location of the powerlines, research by the ATSB has shown that an awareness of powerline location does not guarantee avoidance. The powerline involved was not fitted with high-visibility markers, nor was it required to be, as it was only 39 ft (12 m) above ground level and well away from the runway or any likely flight path. Had the pilot maintained the runway track until 500 ft above the terrain, he would have greatly reduced the risk of contact with obstacles such as the hangars, trees or powerlines.

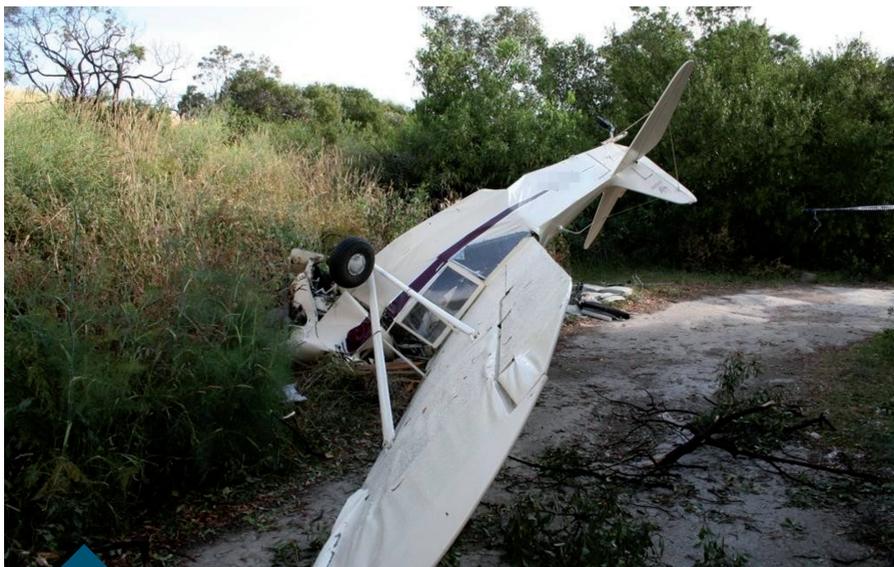
Wreckage of the Auster J1/A1

*Flying at low level gives very little or no margin to recover from unexpected events, such as aerodynamic stalls or engine failures.*

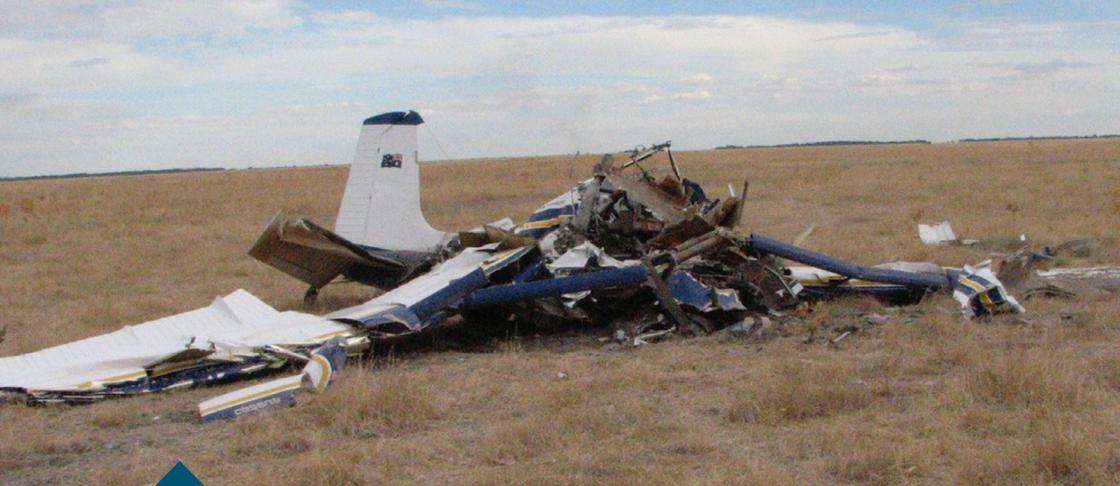
In March 2006, the wreckage of a Cessna 188B Agwagon was found in a paddock near Narrandera, New South Wales. The wreckage showed that the aircraft hit the ground heavily, in a nose-down, right wing low position. The pilot was fatally injured. There were no powerlines or other obstacles in the area near the accident site which may have contributed to the accident.

Wreckage of the Cessna 188B Agwagon

*This accident serves as a salient reminder of the dangers of conducting unauthorised low-flying activities and aerobatic manoeuvres if you are not approved to do so and/or in an aircraft for which those manoeuvres are prohibited.*

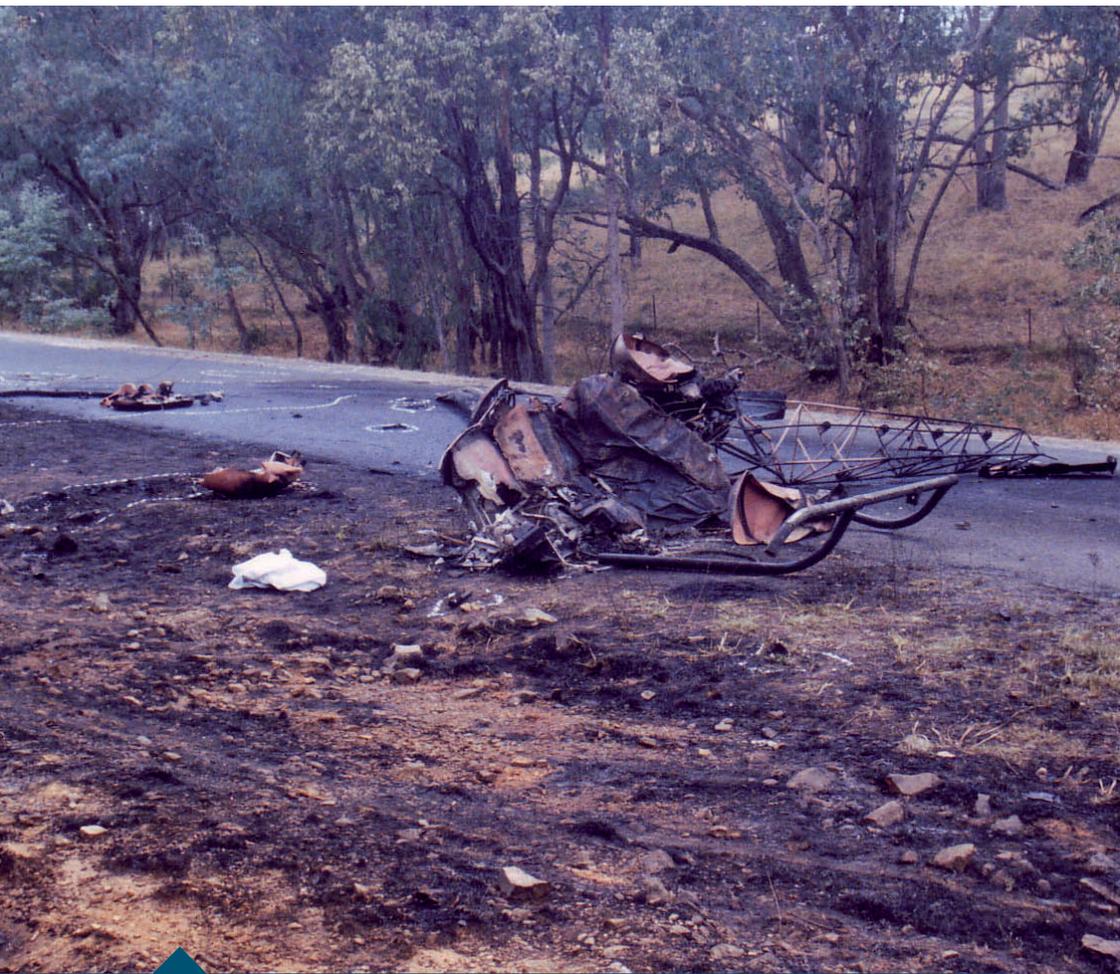
The pilot borrowed an Agusta/Bell 47G helicopter to fly his sister to her wedding at the family property near Holbrook, New South Wales in February 1999. Witnesses reported that the helicopter was flying very low. As it traversed Chinaman's Gap, several kilometres from its destination, the helicopter struck powerlines and impacted the ground. The impact and subsequent fire destroyed the helicopter — brother and sister were killed.

Other pilots, who have regularly flown in the area, reported that the powerline involved (which was 102 ft (31 m) above the ground) was difficult to see because the poles were a long way apart and partially obscured by trees and that the cables blended with the background vegetation.

Wreckage of the Agusta/Bell 47G helicopter

*Powerline poles often provide good visual cues to enable a pilot to see the powerline itself. However, when the span between poles is large, and in particular when the poles are partially obscured by vegetation or other obstacles, this important cue is diminished or unavailable. Pilots should therefore never rely on sighting poles as a sole method for detecting powerlines.*

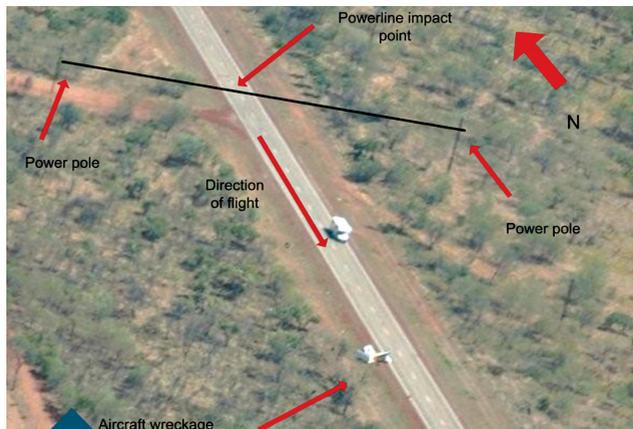
The aircraft's tail section hit a powerline that spanned the Stuart Highway, breaking the tail, which rendered the aircraft uncontrollable. The aircraft impacted the highway in a steep nose-down attitude and came to rest upside down about 150 m from the point where it had impacted the powerline. The aircraft was destroyed and the accident was not survivable.

Investigation of the aircraft wreckage determined that the aircraft's ground speed at the time of the accident was at least 72 kts. The powerline involved in the accident was only 49 ft (15 m) above the road surface.

Aerial view of accident site

*Don't forget that powerlines can be anywhere — even in the desert.*
