Havarikommissionen

Accident Investigation Board Denmark

Report 2022-150

Serious incident to CS-TNV (Airbus A320-214) in Copenhagen/Kastrup (EKCH) on 8-4-2022

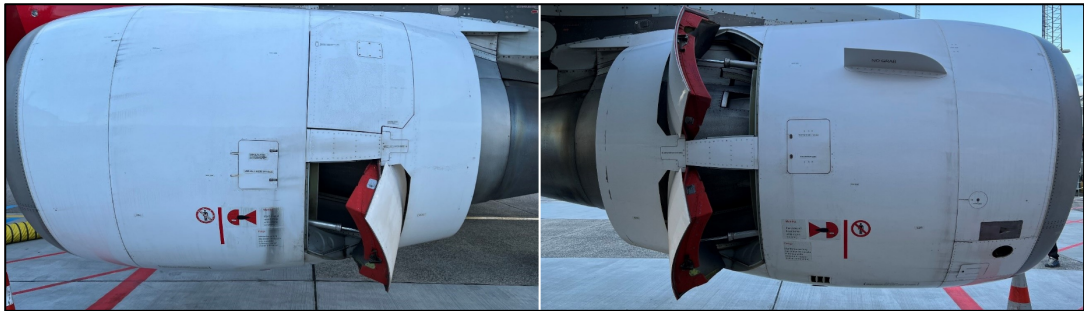
Figure 15. Engine #1 seen from the LH and RH side

The initial inspection on the aircraft stand revealed that engine #1 LH upper blocker door PDL was unlocked, but the actuator secondary lock remained locked i.e. the LH upper blocker door could not be moved to full deployment. The remaining three blocker doors were all fully deployed.

Visual inspections revealed only one small defect on the LH upper door latch roller which was seized. Functional tests of the thrust reverser system with and without engine running showed normal behaviour and no faults.

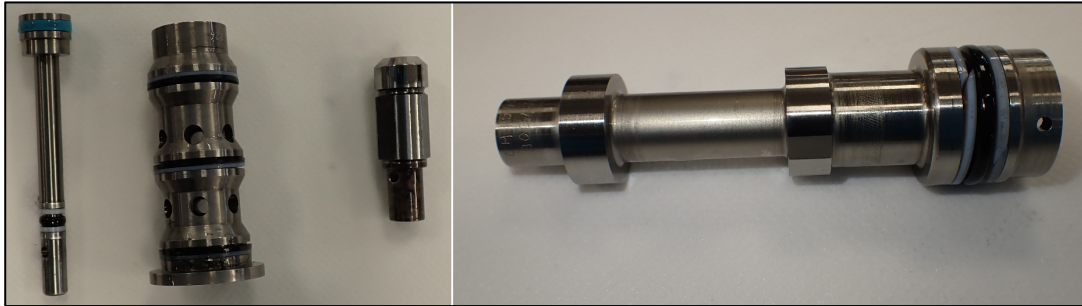
Figure 19. Isolation valve and associated parts shown left, and directional valve shown on the right

To verify that no damage existed on the pressurising valve and the directional valve in the HCU (as this could potentially have resulted in the valves to go periodically stuck), both valves and associated guides and parts were removed and inspected. No defects were found on any of the parts.

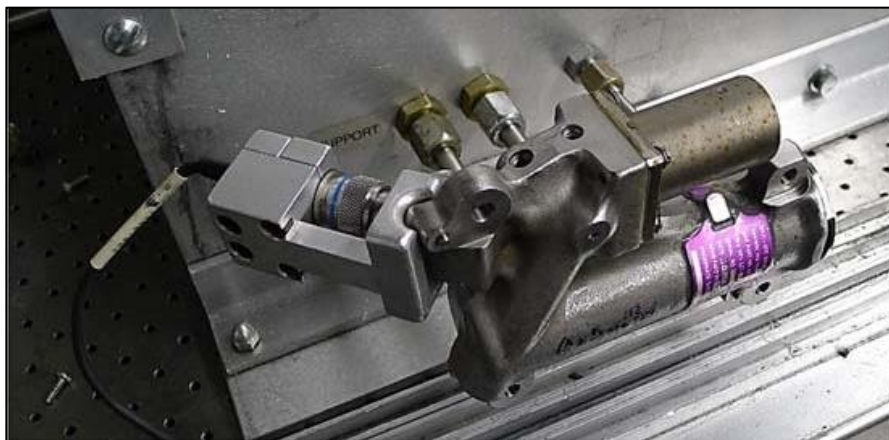
Figure 22. TRSOV in test rig

CMM testing of the component was conducted under the supervision of the NTSB and the FAA. The TRSOV passed all CMM tests.

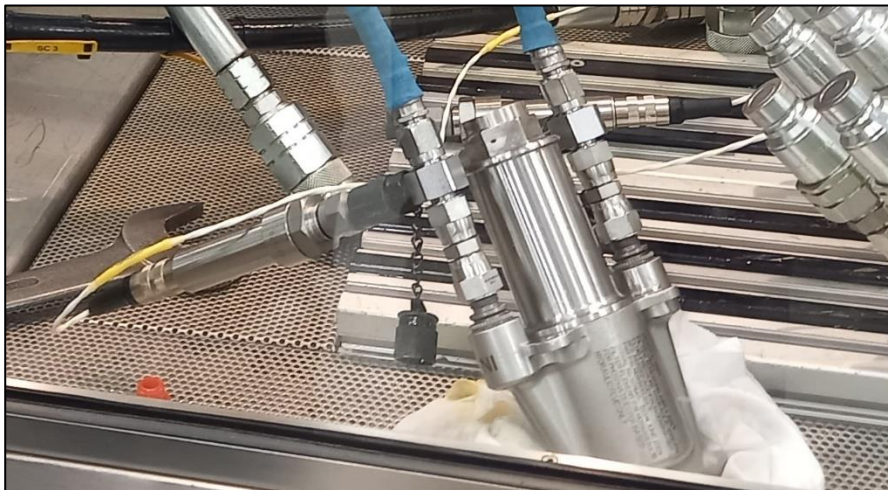
Figure 23. Filter housing test at the operator

The filter housing flow differential pressure test was slightly out of limit, and the shut off valve leak check failed. The operator informed that it had been a challenge in the past to test other filter housings within the CMM limit for the flow differential pressure test.

The leakage of the shut off valve also had no influence on engine #1 thrust reverser's inability to stow.
