**Havarikommisjonen**  
Accident Investigation Board Denmark

## Report 2022-34

**Wheel failure on freight wagon at Ejby on 13-1-2022**

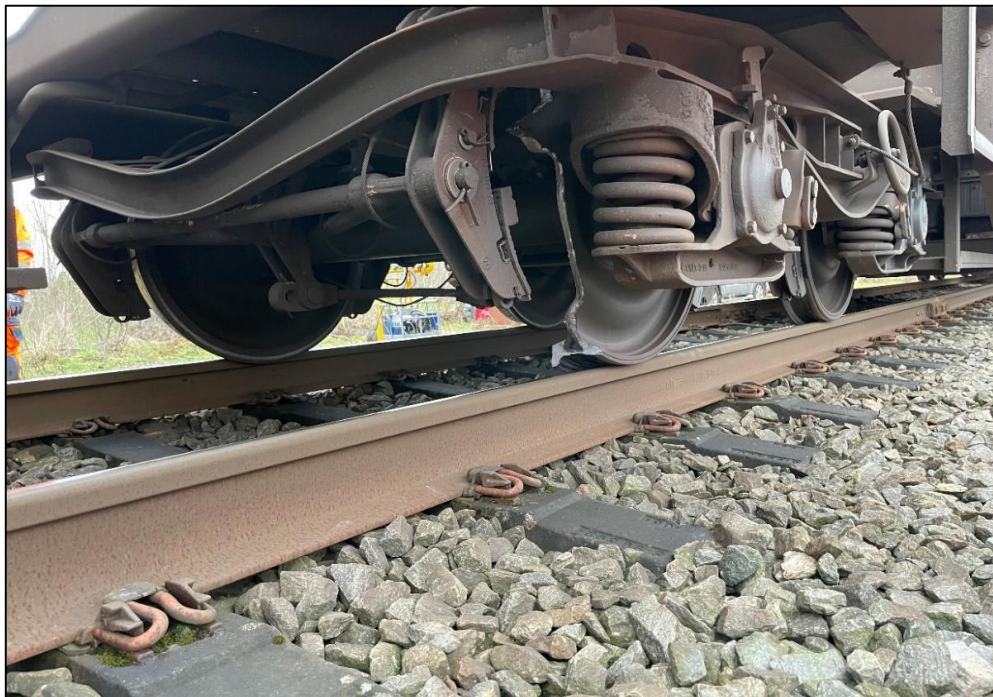
No one was injured during the incident, and the damage was limited to wheel, bogie, brakes and wagon floor.

Photo 1. Axles 3 and 4 on the damaged wagon after stopping in Ejby.

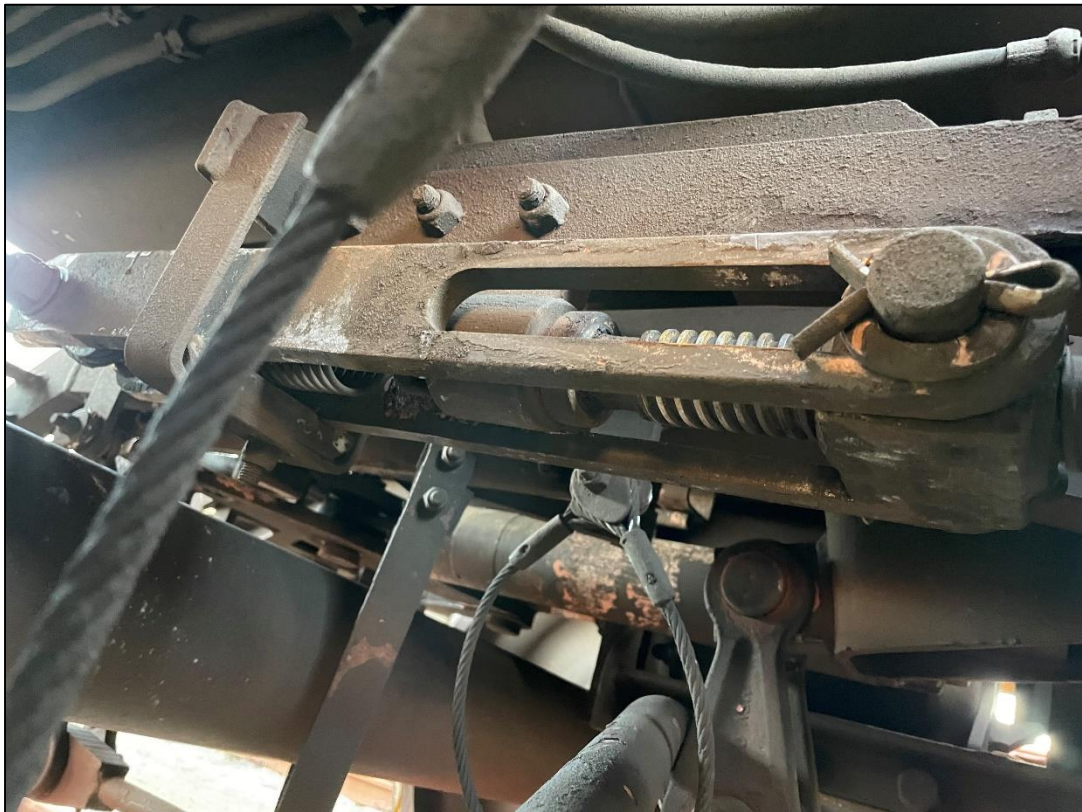
The bogie's hand brake was not in the end position (see photo 2), but due to damage to the brake equipment, it was not possible to determine whether the position of the hand brake meant that the brakes had dragged against the wheels prior to the accident.

Photo 2. Hand brake actuator with threaded rod 8-9 revolutions from the end position.

During the AIB's examination of wagon 33 68 4955 387-8 following the incident on 13-01-2022, it was noted that the hand brake on the bogie in question was not in the end position.

It has not been possible to determine whether the position of the hand brake meant that the brakes had dragged against the wheels prior to the accident due to damage to the brake equipment. However, based on the newly fitted brake blocks not being worn down, it is considered that the brakes on this bogie probably did not drag on the journey from Krefeld. There was no record of dragging brakes on train 42702 on 13-01-2022.

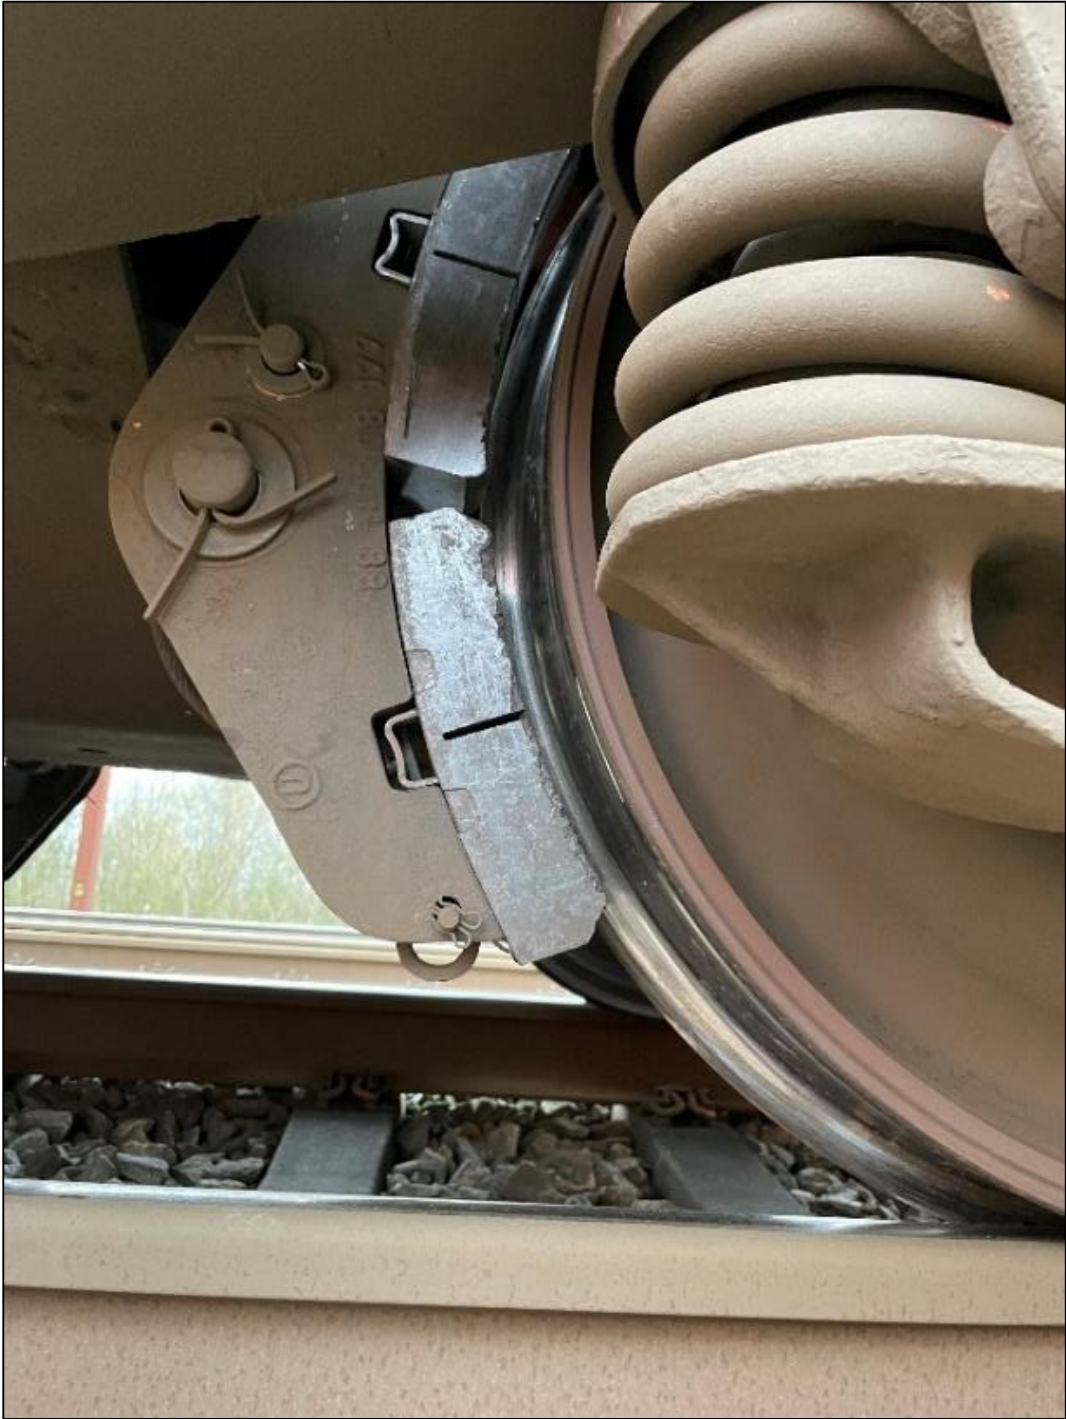
The brake blocks around the broken wheel were damaged. Eight of the 16 brake blocks on the centre bogie were new (two on each wheel) (see photo 3).

Photo 3. New brake blocks. The wagon's 3rd axle on the right-hand side.

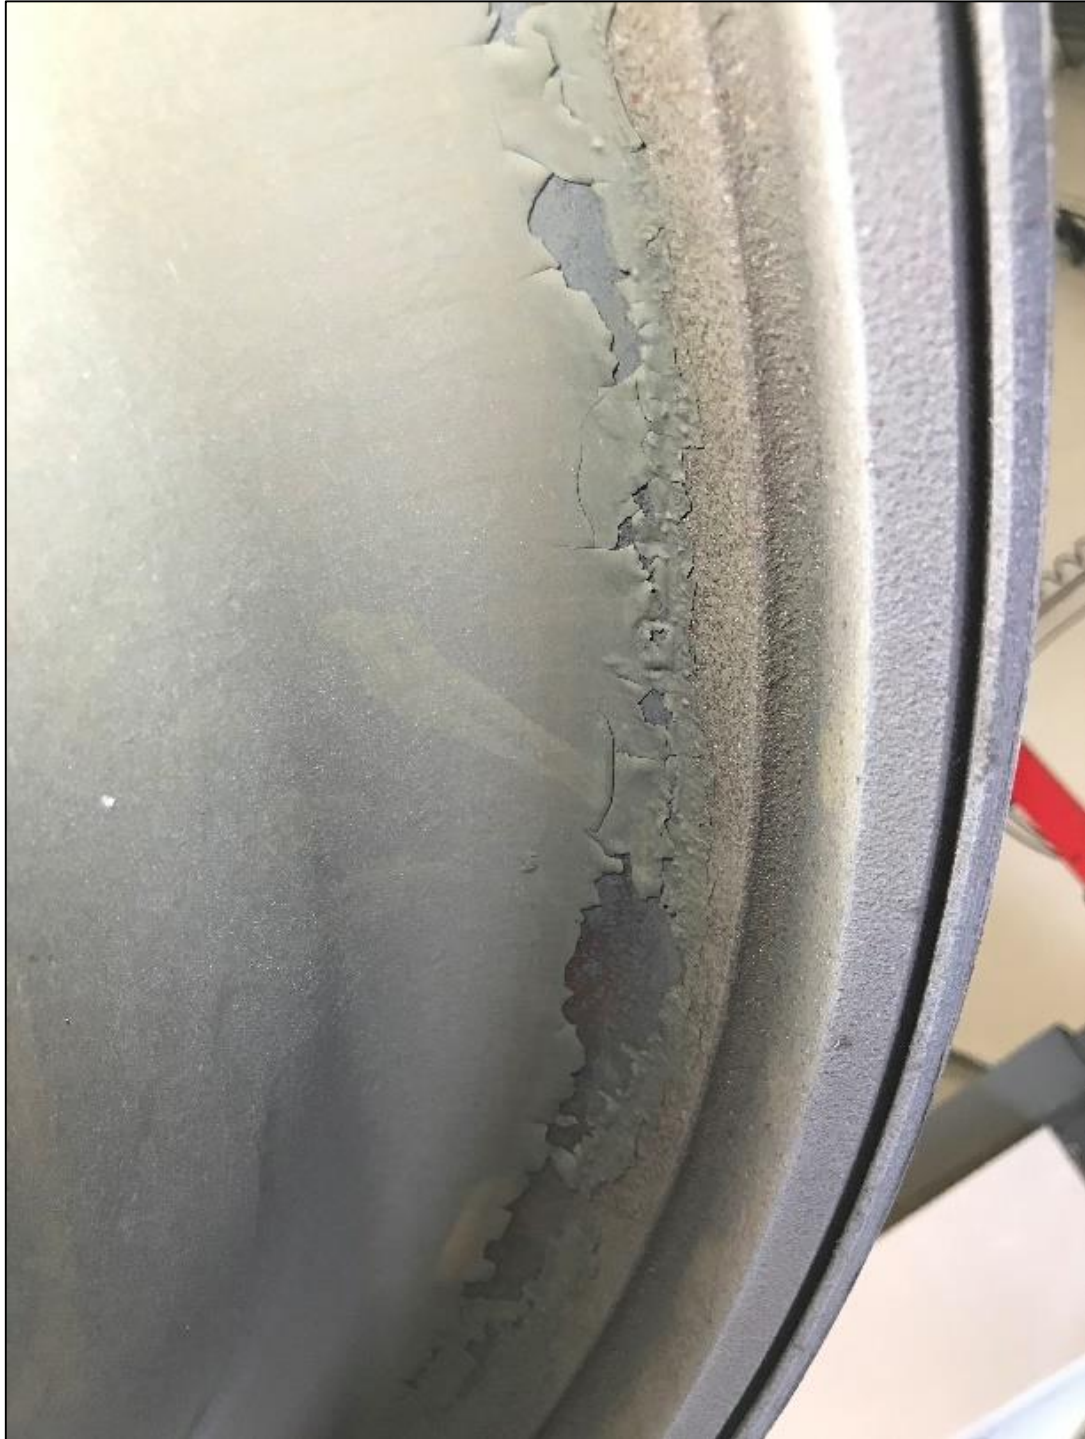
The wheelset which was fitted to axle 3 had the number 85 19 147 193 and was of the BA004 type. It showed signs of thermal overload, with both burnt paint and deformation of the wheel tread. The burnt paint was approx. 20 mm up the wheel plate and is considered to predate the most recent use of the wagon due to the presence of corrosion around the burnt paint (see photo 4). The wheel diameter had not been written on the inner side of the wheel and was measured at 840 to 848 mm (ovality) after the incident.

Photo 4. Burnt paint and corrosion in the transition between wheel plate and wheel rim.

On the day before the incident, a maintenance provider with a mobile workshop replaced some of the wagon's brake blocks, including four on the wheelset that subsequently failed. The wheelset probably was showing signs of thermal overloading by this point in time, but the burnt paint was less than 50 mm and thus under the de minimis limit for the mobile workshop. This is probably the reason why the wheelset was not investigated further. The investigation has shown that the wheel was oval and the outside of the running surface was deformed. The deformity was probably caused by one or more events with thermal overload, but the heat generation at this/these events did not result in burnt paint of more than approx. 20 mm in the transition zone between wheel plate and wheel rim.

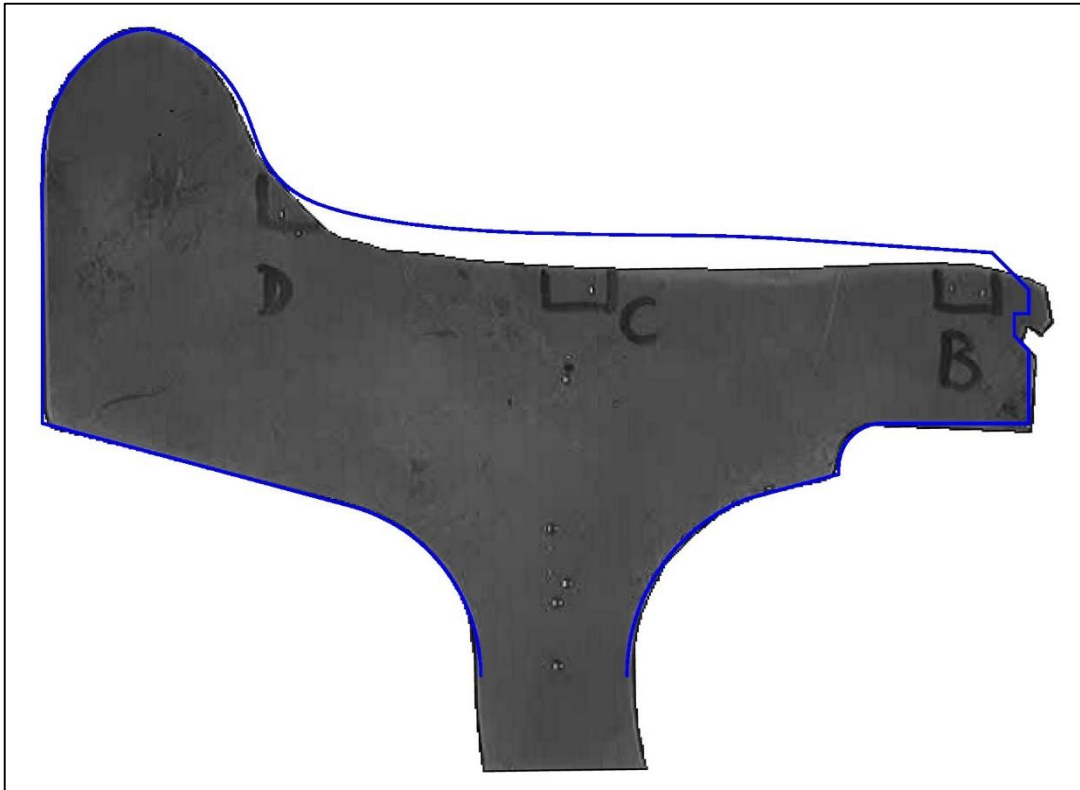
Figure 1. Wheel profile for the damaged wheel (Grey) compared with wheel profile according to EN 13715, at 862 mm (Blue line).

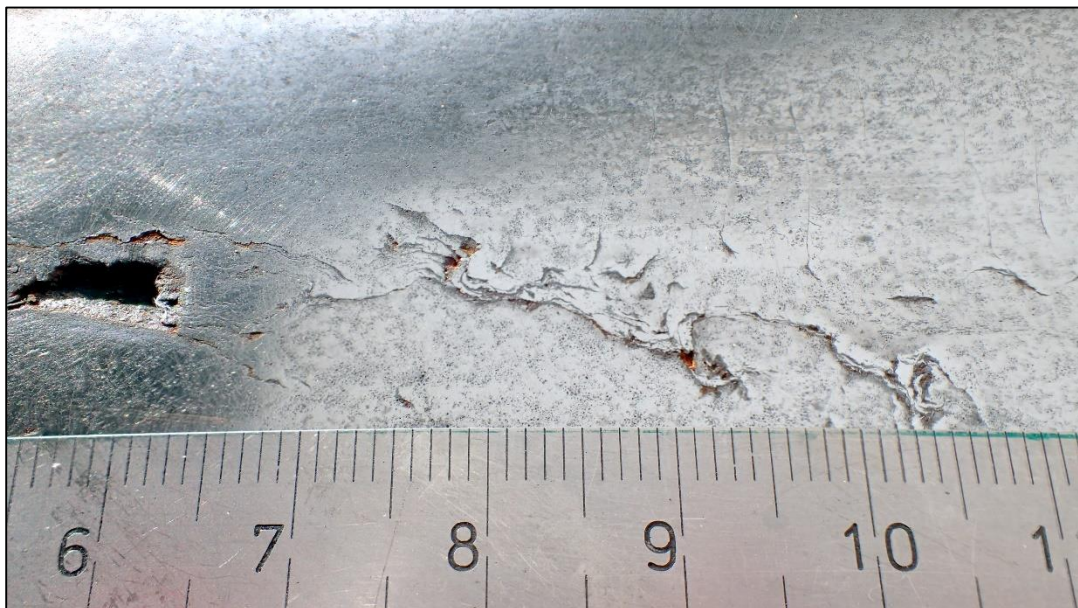
At the request of AIB, Force Technology has investigated the failed wheelset. Signs of crack formation and material loss were visible on the treads of both wheels (see photo 5).

Photo 5. Close-up photograph of the intact wheel on wheelset 8519147193 showing cracks and material loss. The scale on the ruler shows cm. Source: Force Technology.

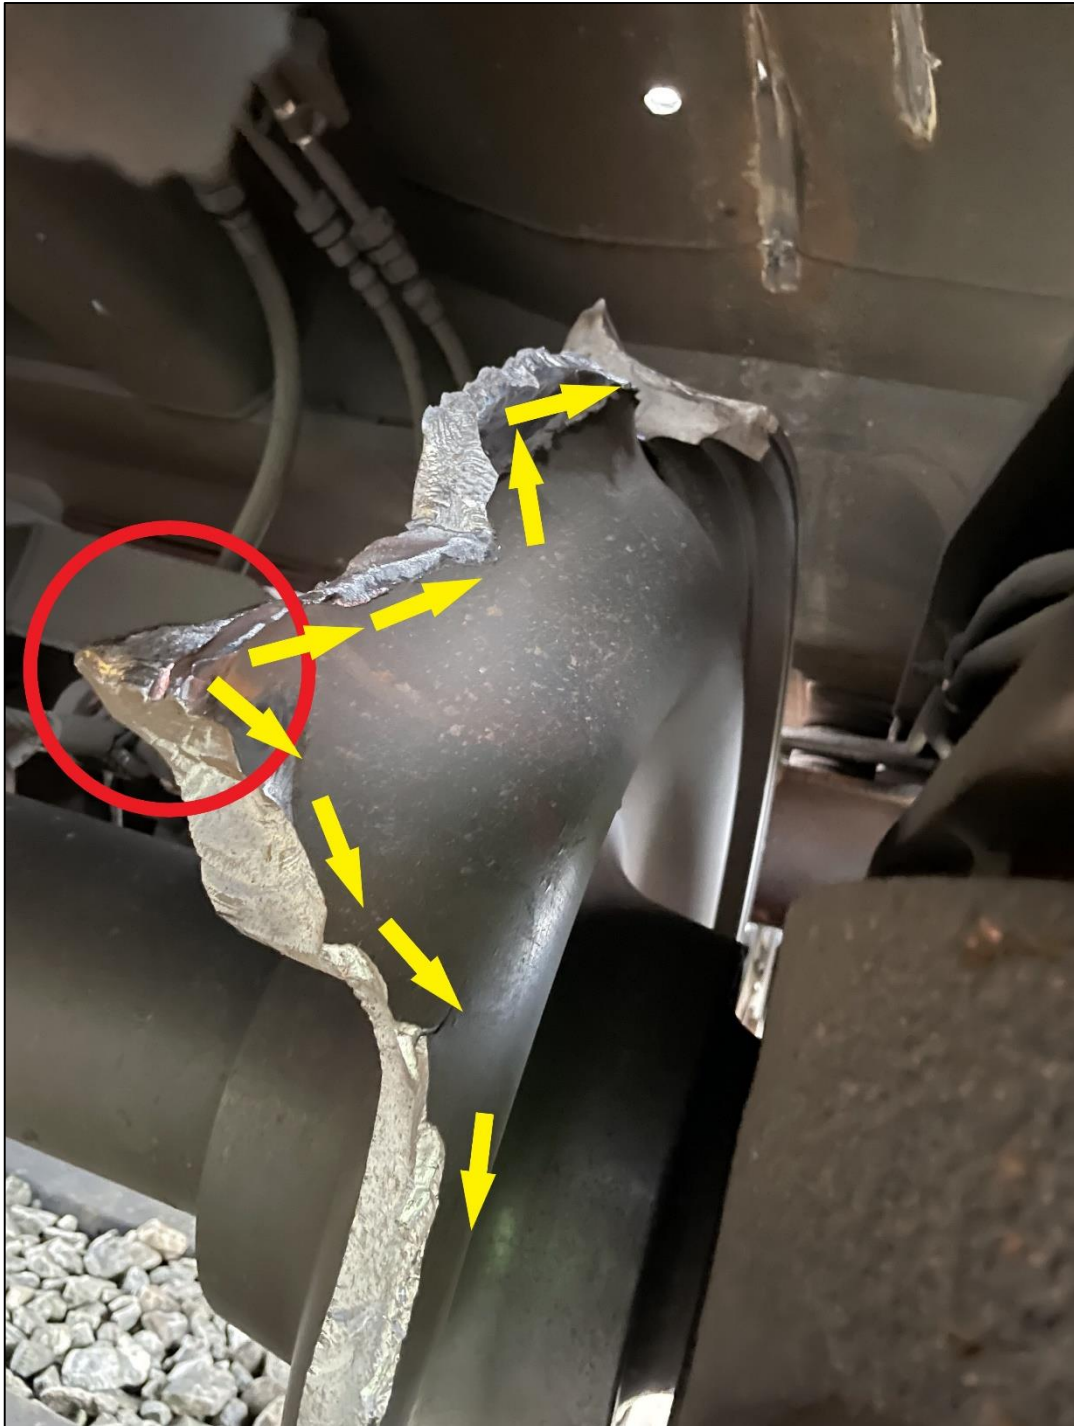
The investigation revealed that a fatigue crack had developed in the transition zone between the wheel plate and wheel rim on the outside of the wheel. See Figures 1 and 2.

The direction of propagation was clearly indicated by the curved failure lines. See Figures 1 and 2, and photo 6.

Figure 2. Initiation point (starting point) and direction of propagation. Source: Force Technology.

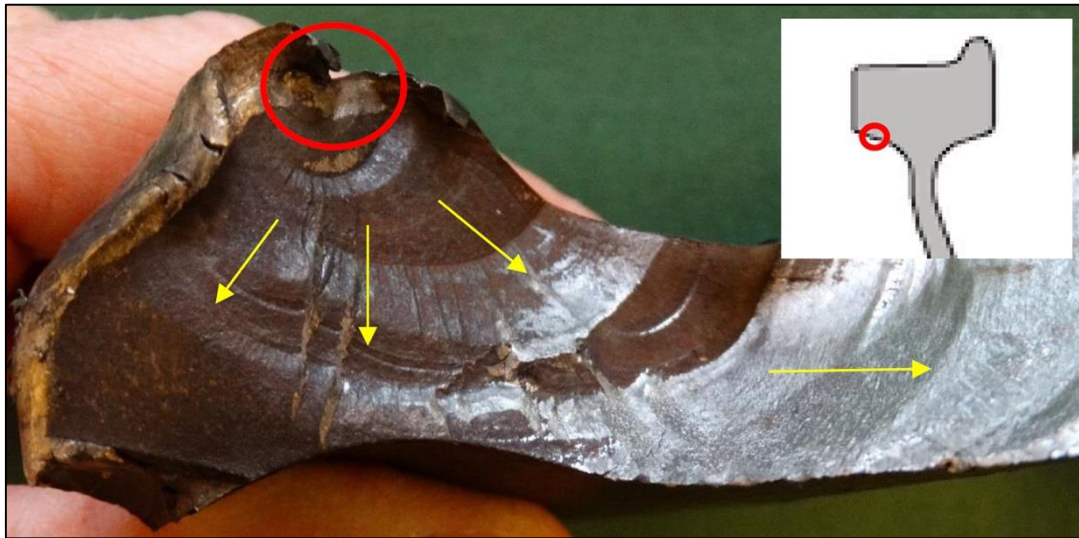
Figure 3. Initiation point and direction of propagation, before cleaning. Source: Force Technology.

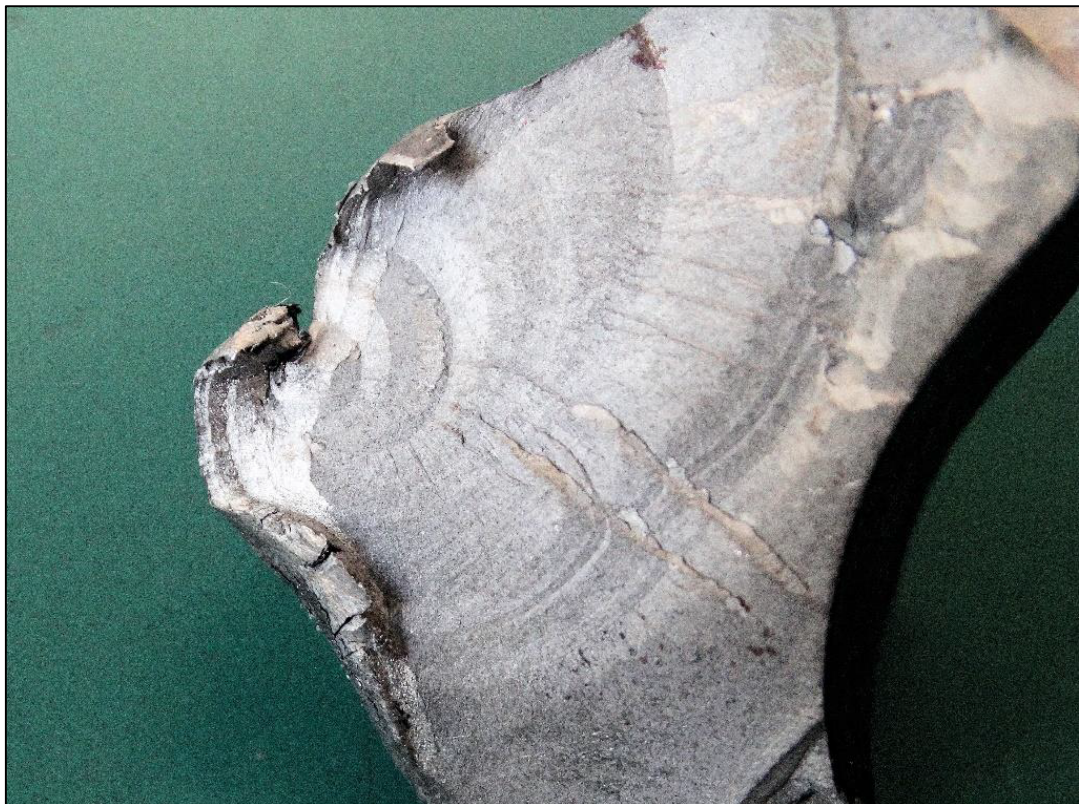
Photo 6. Initiation point after cleaning with Alconox®. Source: Force Technology.

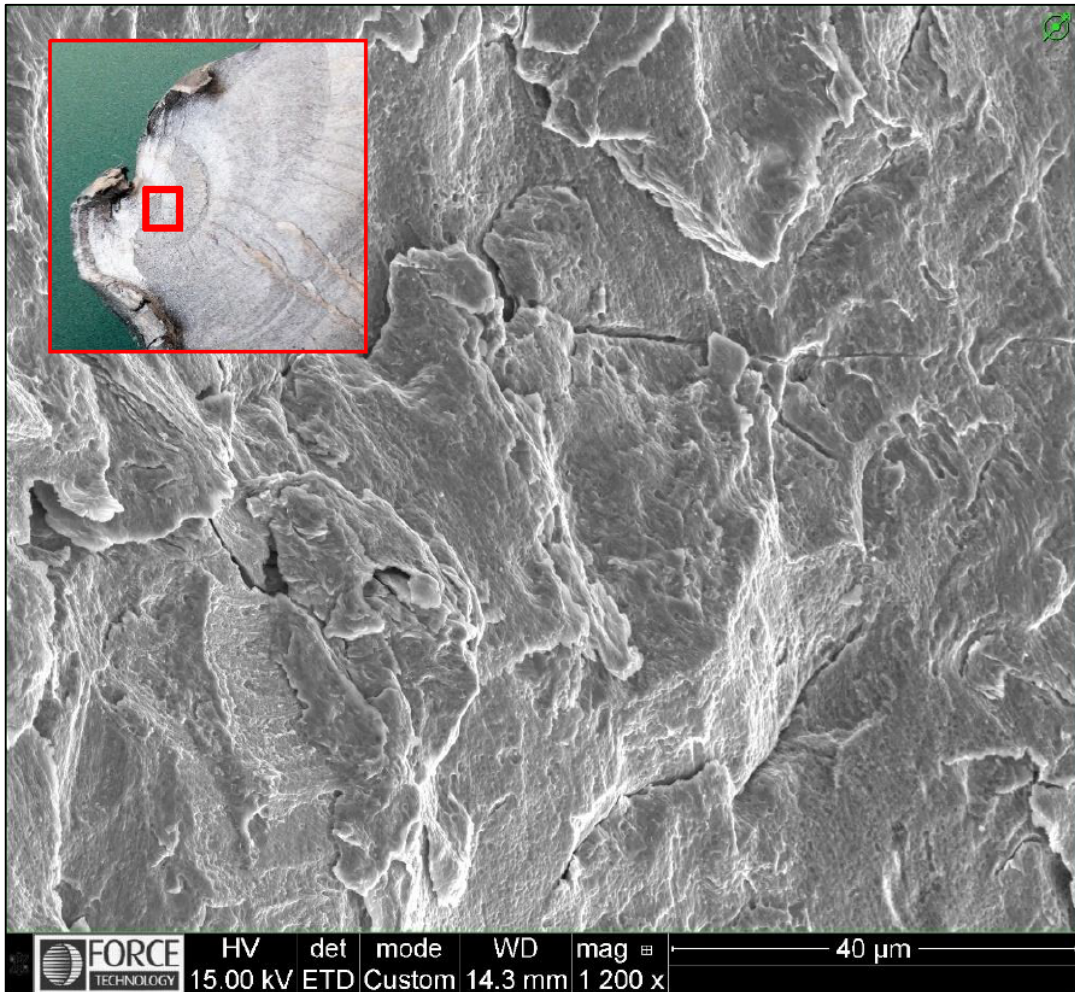
Scanning electron microscopy (SEM) revealed no visible imperfections in the fracture origin (see Figure 3).

Figure 4. No visible imperfections in the fracture origin. Source: Force Technology.

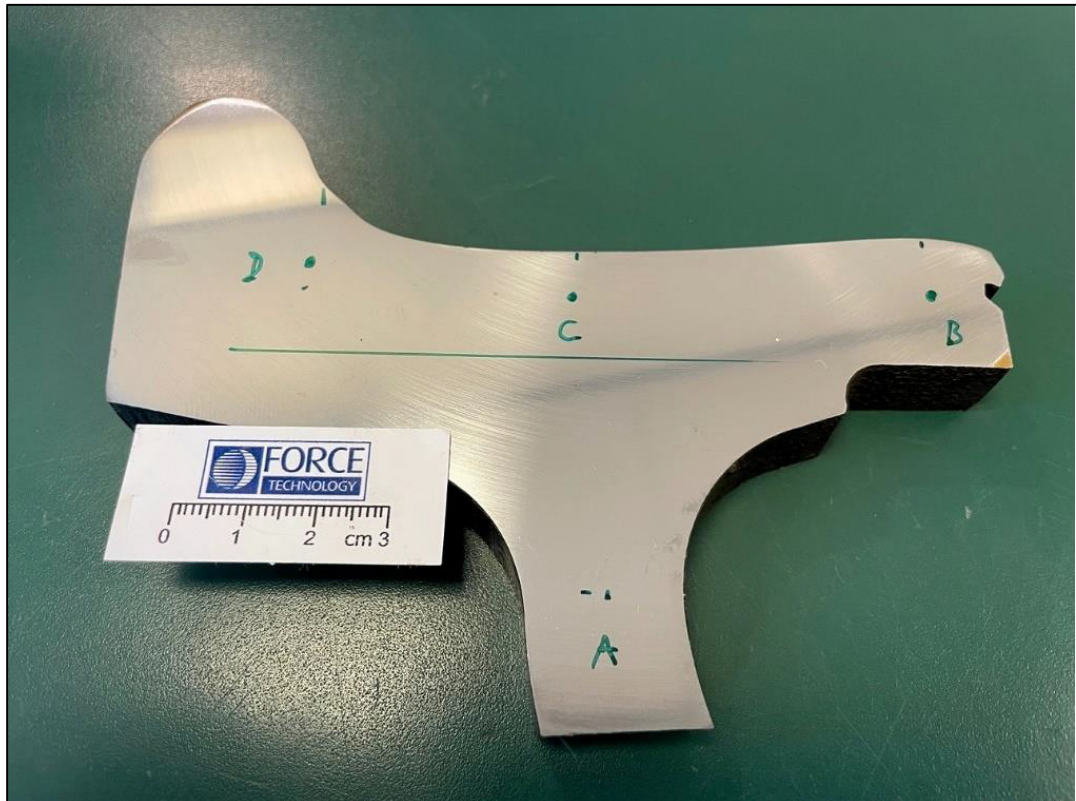
These measurement points were therefore moved 3 mm down below the wear limit (see photo 7). At these points, the hardness was considerably above the requirement specified in EN 13262. Further down below the wear limit, the hardness was measured to be considerably below the requirement specified in EN 13262.

Photo 7. Section for hardness testing, with the test points marked. Source: Force Technology.
