Havarikommisjonen

Bulletin 2020-329

Serious incident to OY-LUN (Champion 8KCAB) in Roskilde Terminal Control Area on 10-9-2020.

ISSUED SEPTEMBER 2021

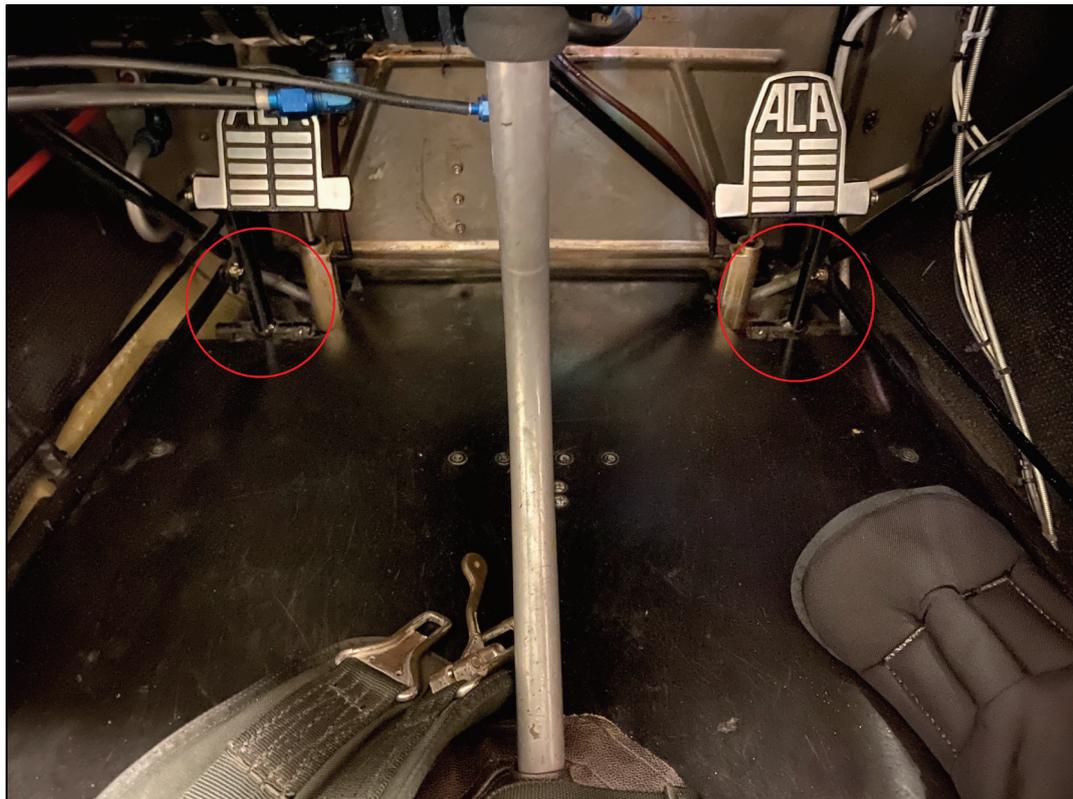
The floor openings for the front seat rudder pedals were unprotected – see figure 1:

Figure 1. Rudder pedals floor openings (marked by red circles)

The two forward pedal floor openings, openings between the front floorboards and the cabin sidewalls, and the opening between the left sidewall panel and the aft lateral panel allowed access for small loose items from the cockpit to the aircraft belly. In addition, smaller openings like holes for control cables in the aileron bellcrank enclosure etc. existed.

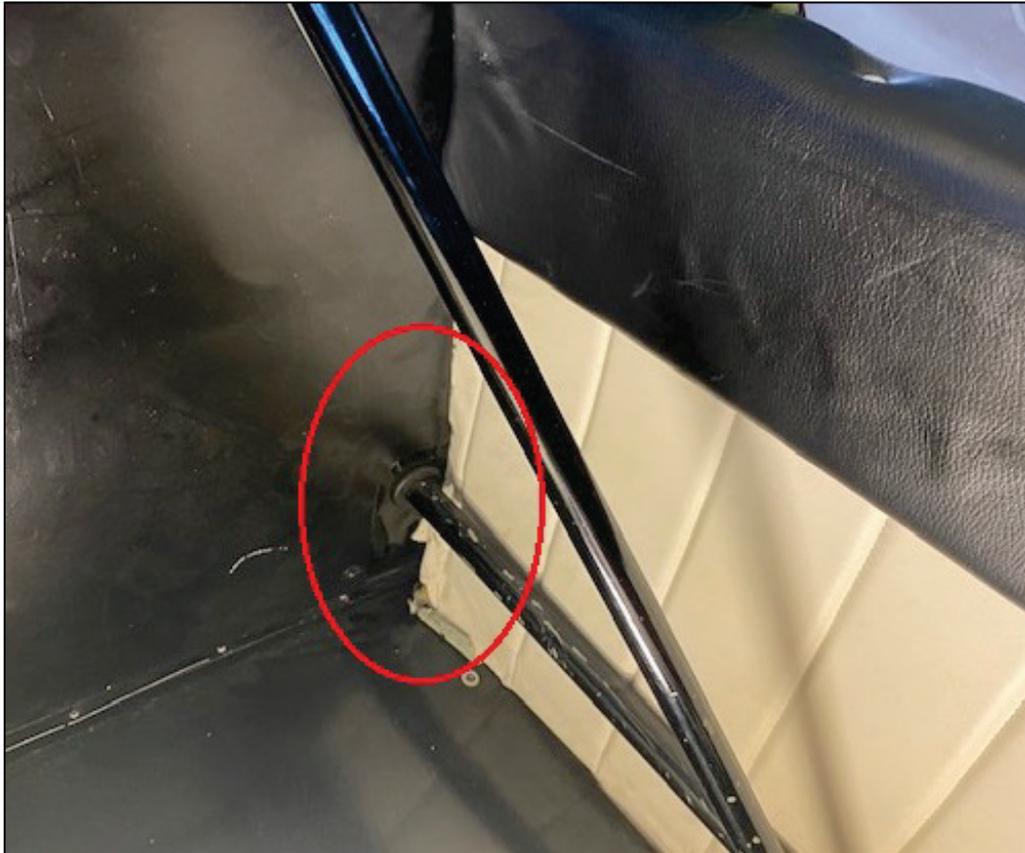
A narrow opening existed between the left sidewall panel and the aft lateral panel – see figure 2:

Figure 2. Aft cockpit opening (marked by red circle)

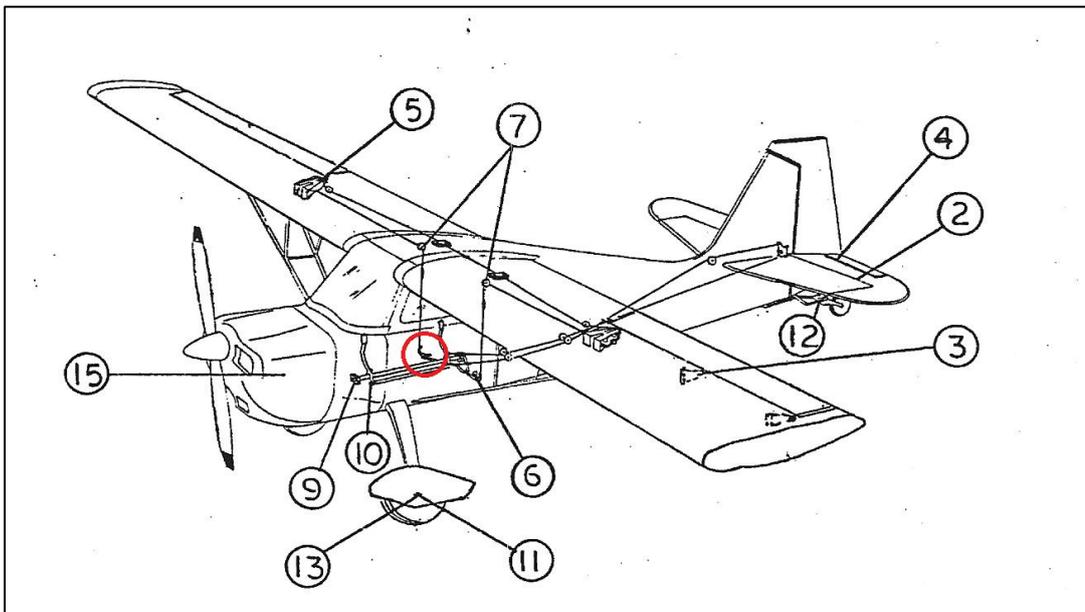
A technical inspection of the aircraft revealed a ballpoint pen stuck in the right hand no. 6 aileron sector – see figure 3:

Figure 3. No. 6 aileron sector (right hand side marked by red circle)

During the upset recovery training, manoeuvring with both positive and negative G-forces probably allowed the ballpoint pen to move from the tail compartment to the sector no. 6 aileron enclosure.

Eventually, the ballpoint pen became stuck in the bellcrank mechanism partially blocking aileron movement.

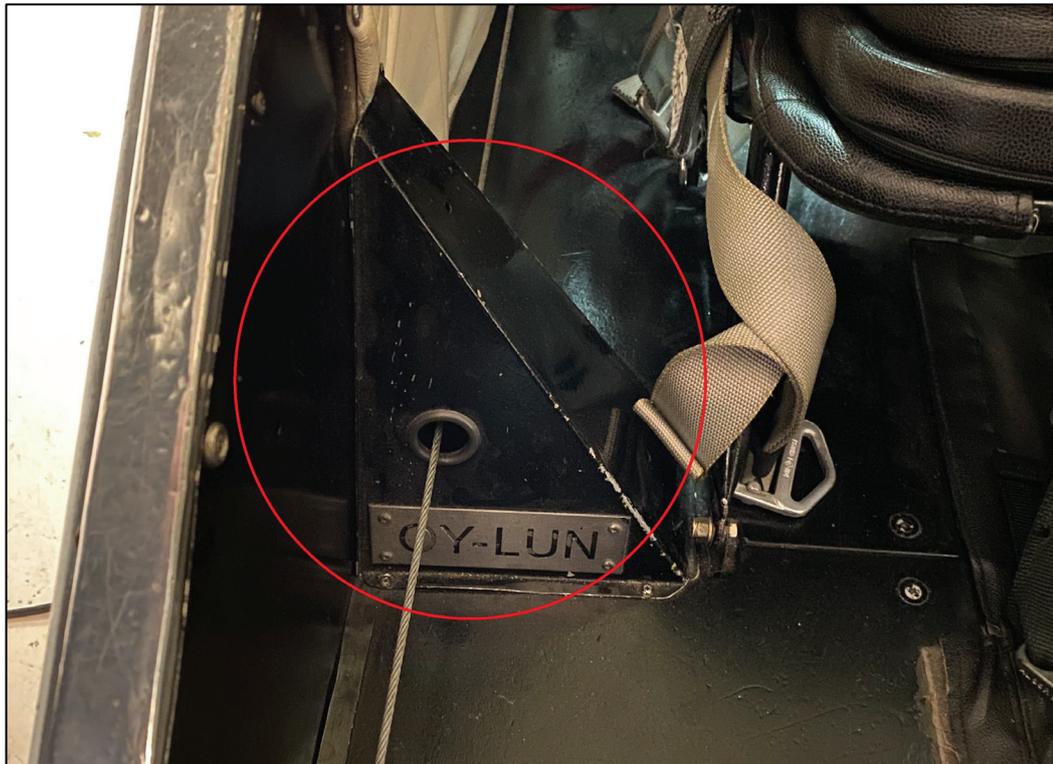
The right hand side aileron bellcrank (sector no. 6) enclosure protruded from the aircraft floor, with the empennage control cable running through the enclosure - see figure 4:

Figure 4. Right hand side aileron bellcrank enclosure (marked by red circle)

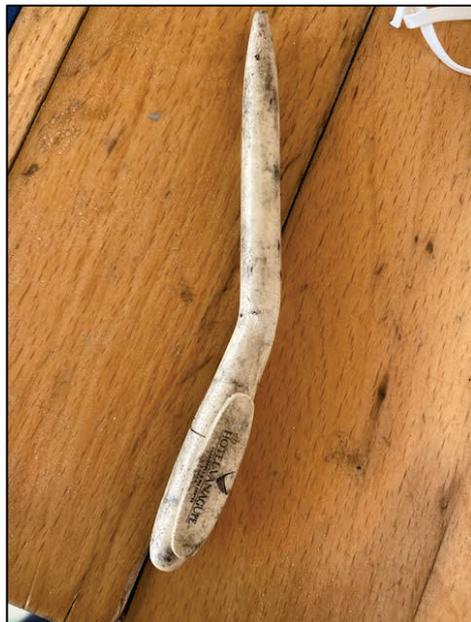
Figure 5. Ballpoint pen

It seems likely that the ballpoint pen was lost in the aircraft cockpit and entered the aircraft belly through one of the above-mentioned larger openings. This likely occurred after the latest 100-flight hour maintenance inspection and before the serious incident flight.

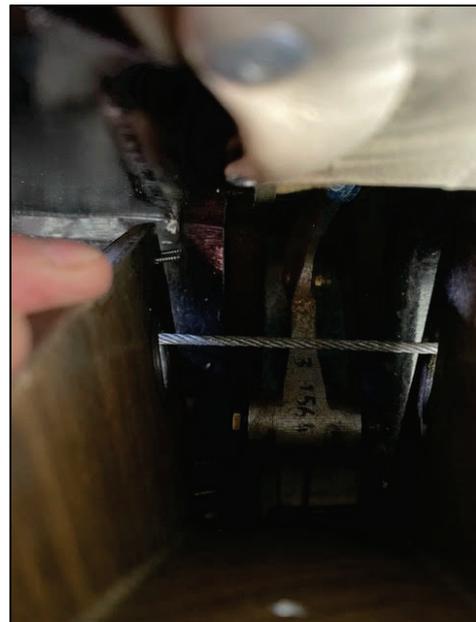
Figure 6. Aileron bellcrank and empennage control cable (seen from above)
