BULLETIN

Serious incident

17-7-2019

Cirrus SR22

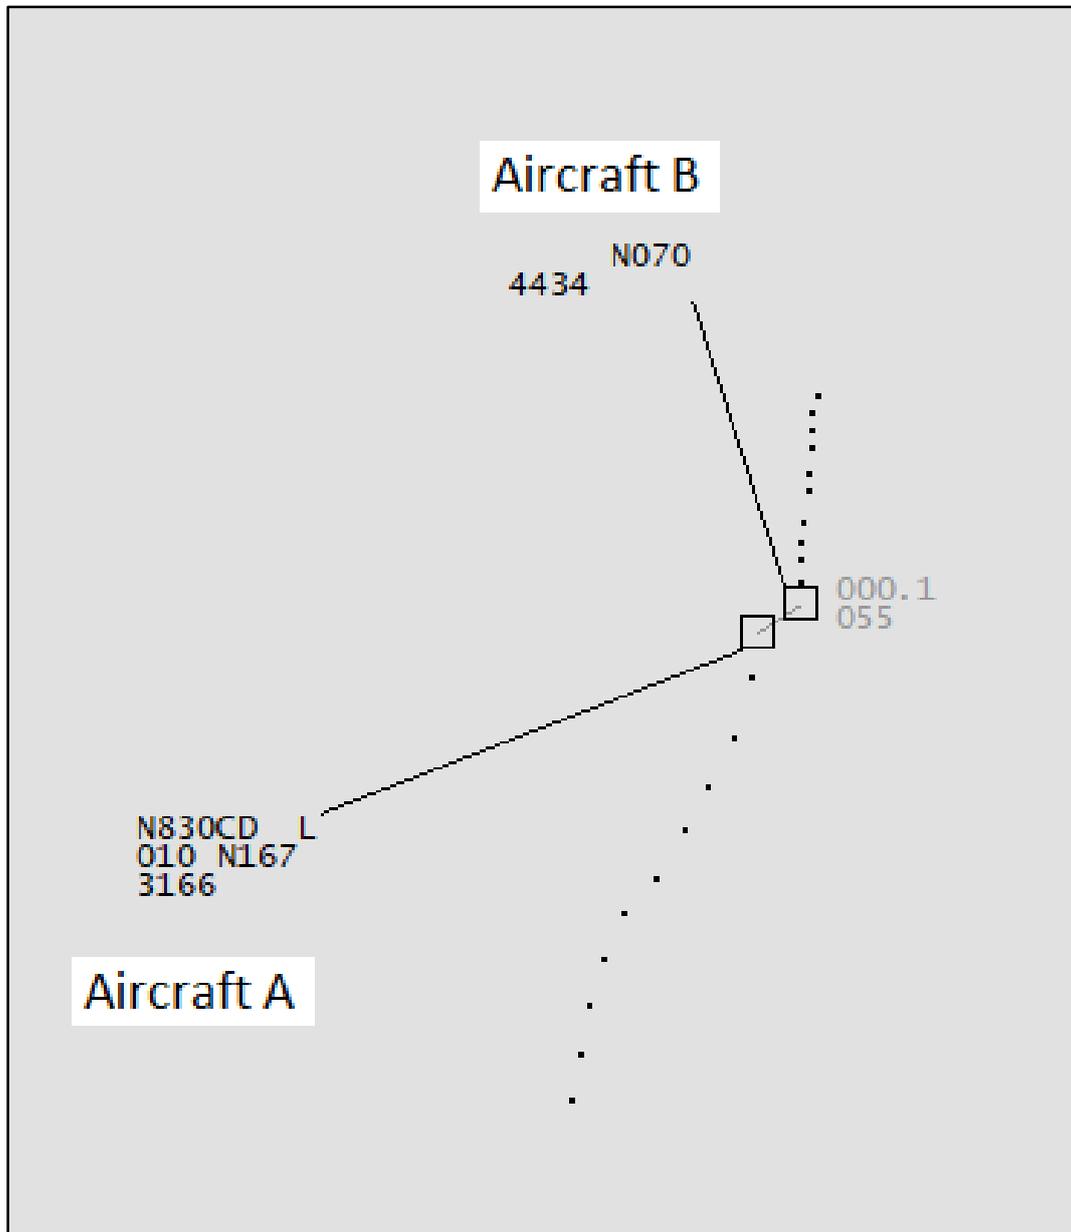
APPENDIX 2 RADAR PRESENTED SEPARATION

Aircraft A and B flew on conflicting opposite tracks, and the aircraft passed each other at a horizontal distance of approximately 0.1 nautical miles (nm) and vertically within 150 feet (ft).

The radar presented horizontal separation between aircraft A and B was 0.1 nm – [see appendix 2](#)

The student pilot estimated the vertical separation between aircraft A and B to be approximately 150 ft, while aircraft A passed overhead aircraft B.

AIB software program presented radar data of aircraft A and B.

The minimum horizontal separation was radar presented as 0.1 nm.

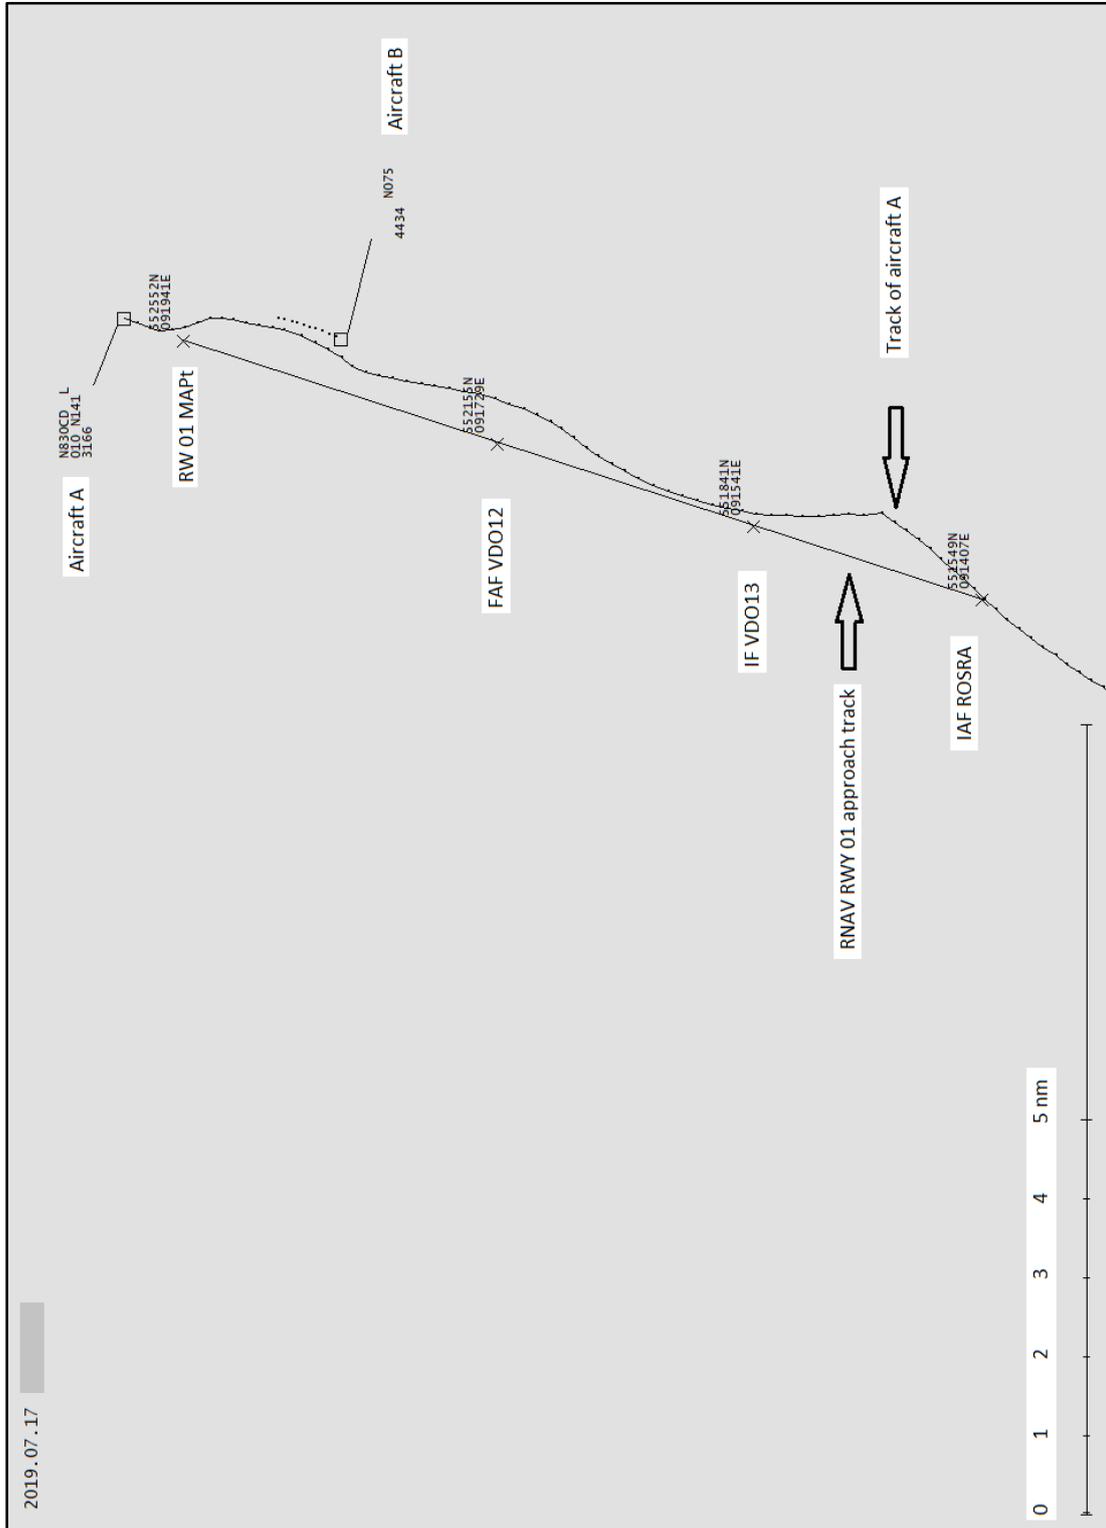
APPENDIX 4 APPROACH TRACK OF AIRCRAFT A

- *The pilot experienced at the beginning of the approach some problems with keeping the track, and he stayed a little on the right side of the track.*
- *The MDA was 560 ft but the circuit altitude was 700 ft, but we did not see any airplanes so we decided to stay at 1000 ft, or above, and made a right hand circuit and then we landed. Normally the circuit altitude of a VFR airport is 700 ft, and then the MDA should also be 700 ft.*

The AIB superimposed the RNAV (GNSS) RWY 01 approach track (IAF, intermediate fix (IF), FAF and missed approach point (MAPt)) onto a software system presentation of the radar recorded approach track of aircraft A.

The IAF, IF, FAF and MAPt lat/long positions were obtained from the AIP Denmark and inserted into the software system in a 6-digit lat/long format – [see appendix 4](#)

The radar presented groundspeeds of aircraft A between the FAF and closest aircraft passage were 156-176 kt, presenting 167 kt at aircraft passage.

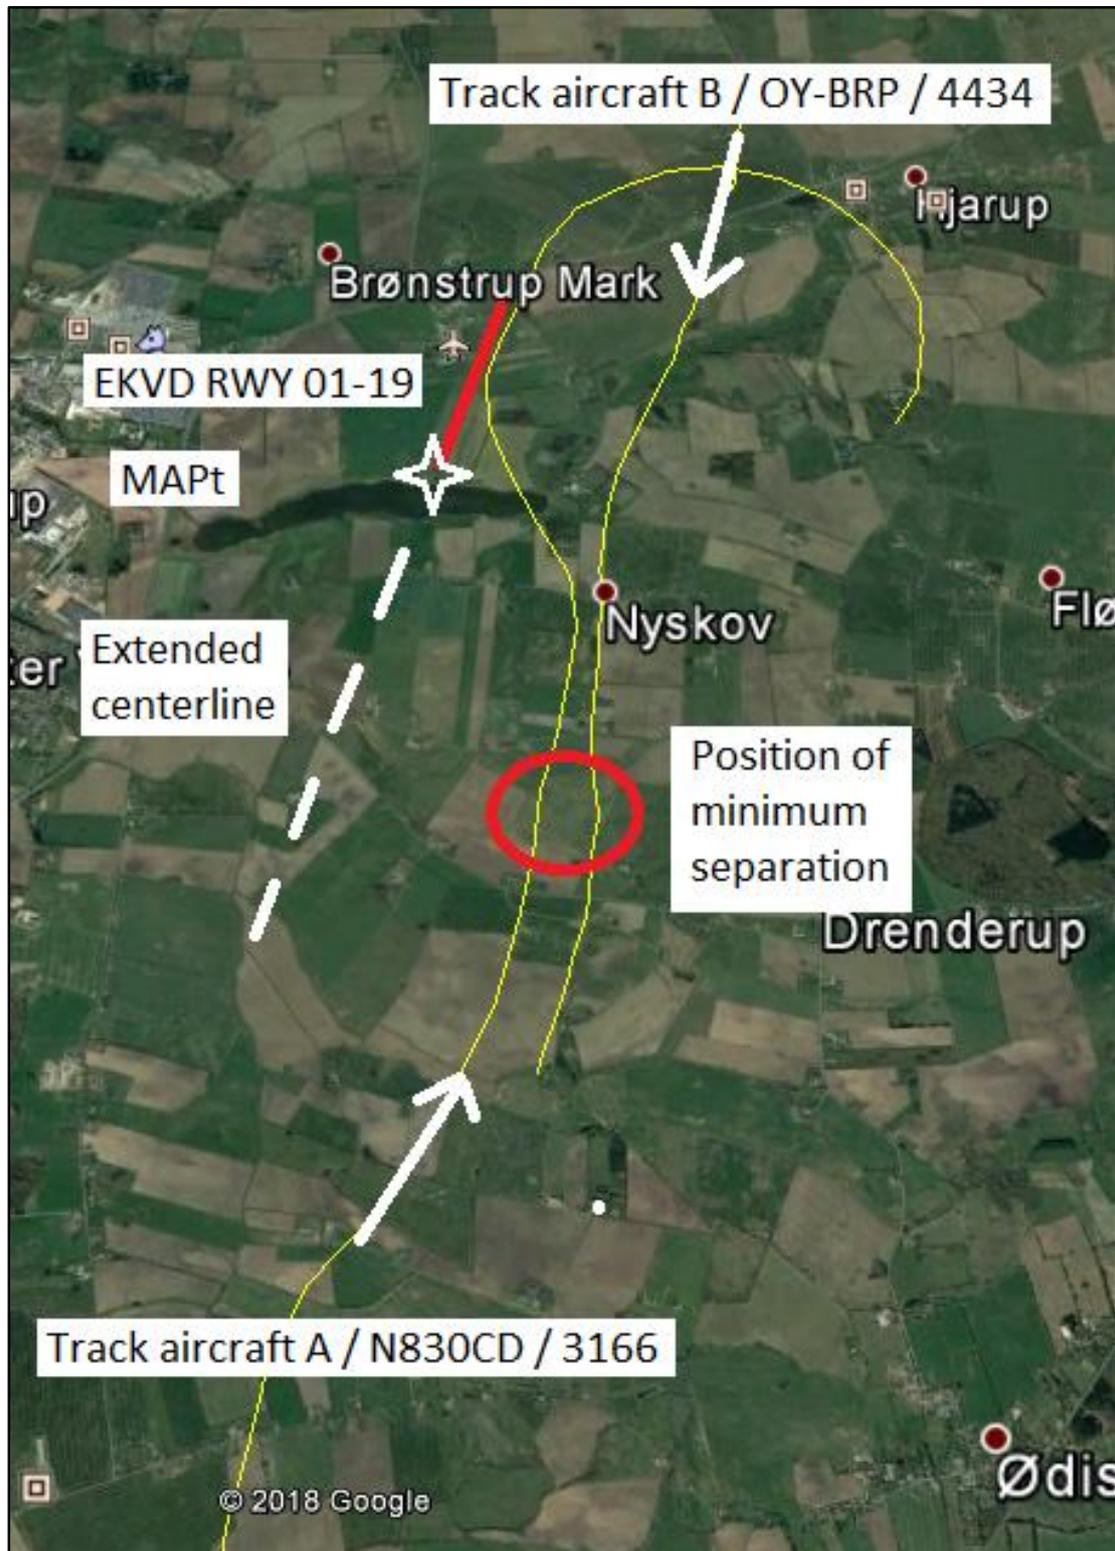
APPENDIX 5 TRACK OVERVIEW

The position of aircraft A when passing aircraft B was approximately 0.5 nm right of the final approach of track (cross-track deviation) and with a distance of approximately 1.0 nm to the MAPt.

The AIB superimposed EKVD, the RNAV (GNSS) RWY 01 MAPt, the extended centreline of runway 01, the tracks of aircraft A and B, and the approximate position of the minimum separation between aircraft A and B onto a Google Maps image – [see appendix 5](#)
