Havarikommissionen
Accident Investigation Board Denmark

BULLETIN

BAE AVRO RJ100

AIRBUS A340

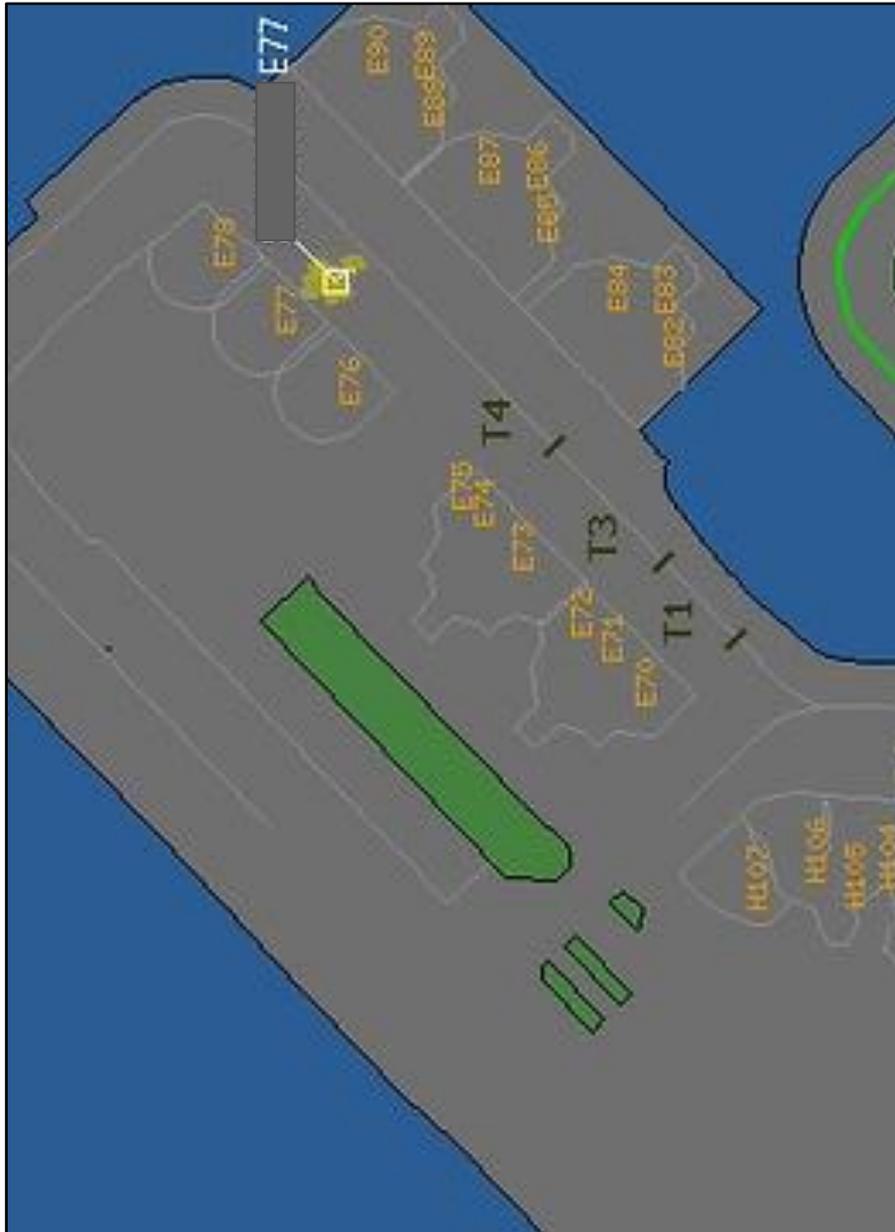
APPENDIX 1

Arriving at aircraft stand E77 at 14:57 hours, the flight crew of SE-DST noticed that the ground handling personnel had not yet arrived at the aircraft stand. By radio in order to request ground handling assistance, the flight crew of SE-DST several times contacted their handling agent.

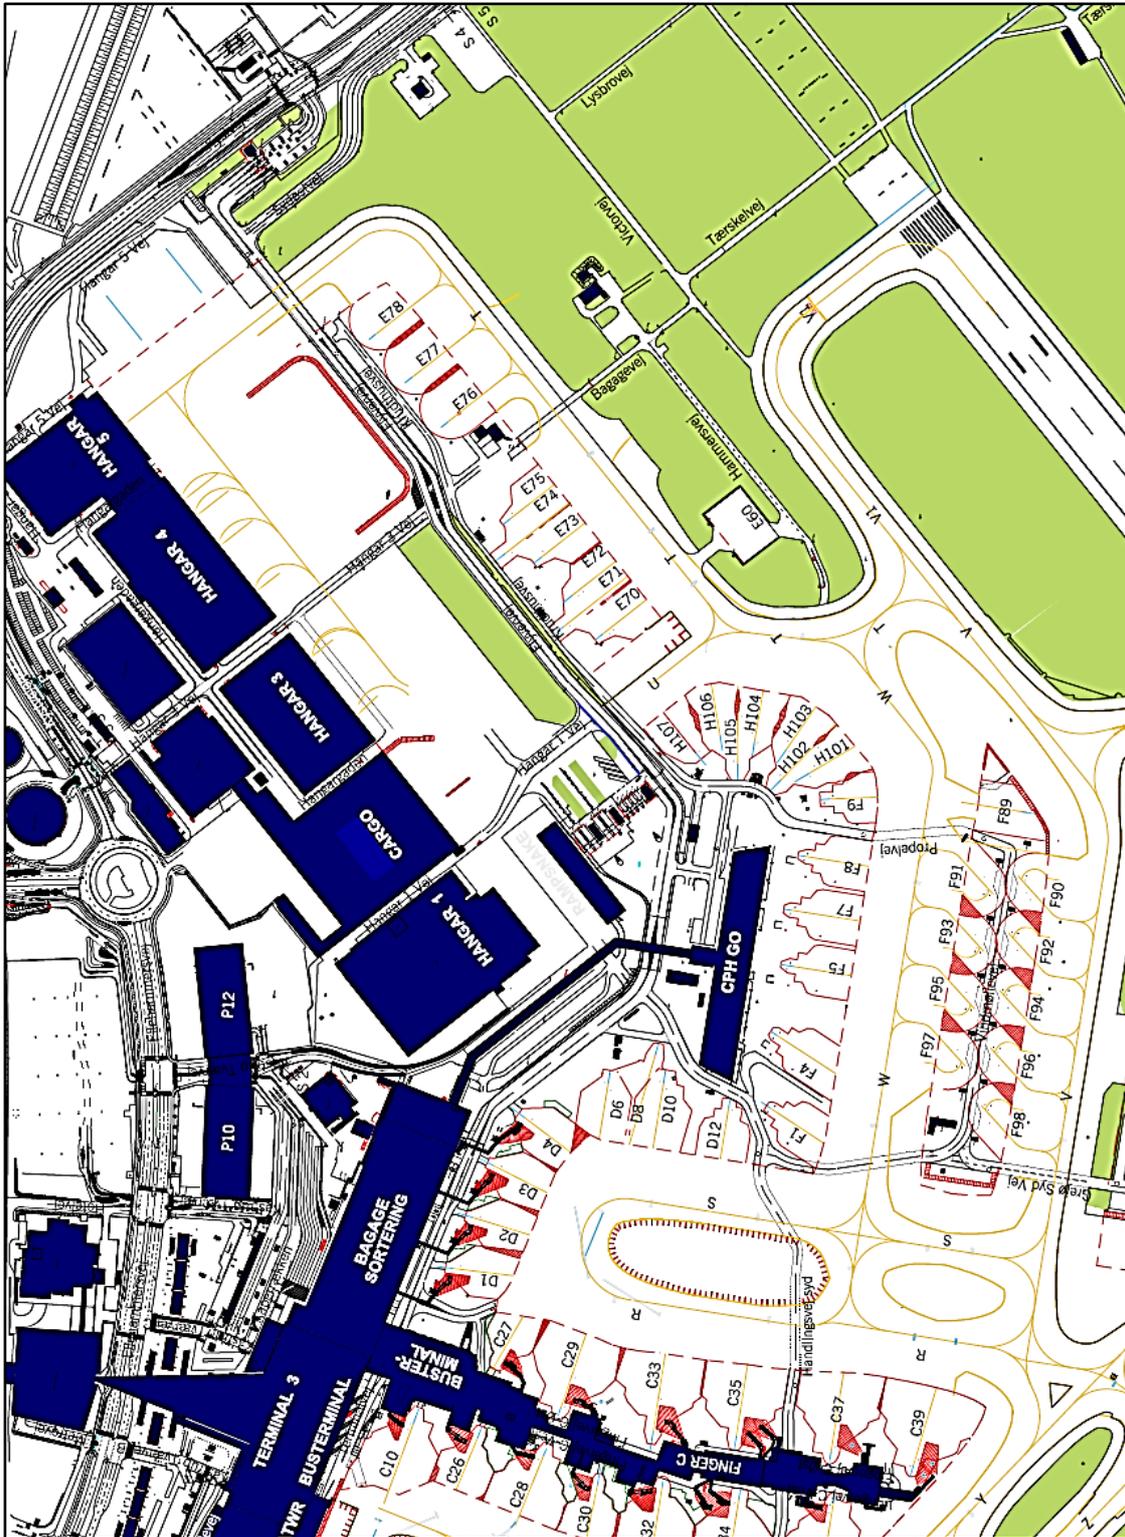
APPENDIX 2

At 15:07:50 hours, Kastrup Apron instructed the TBL driver to tow OY-KBC to aircraft stand C29 via taxiway T, taxiway V and to hold short of taxiway S. The TBL driver read back the towing instructions.

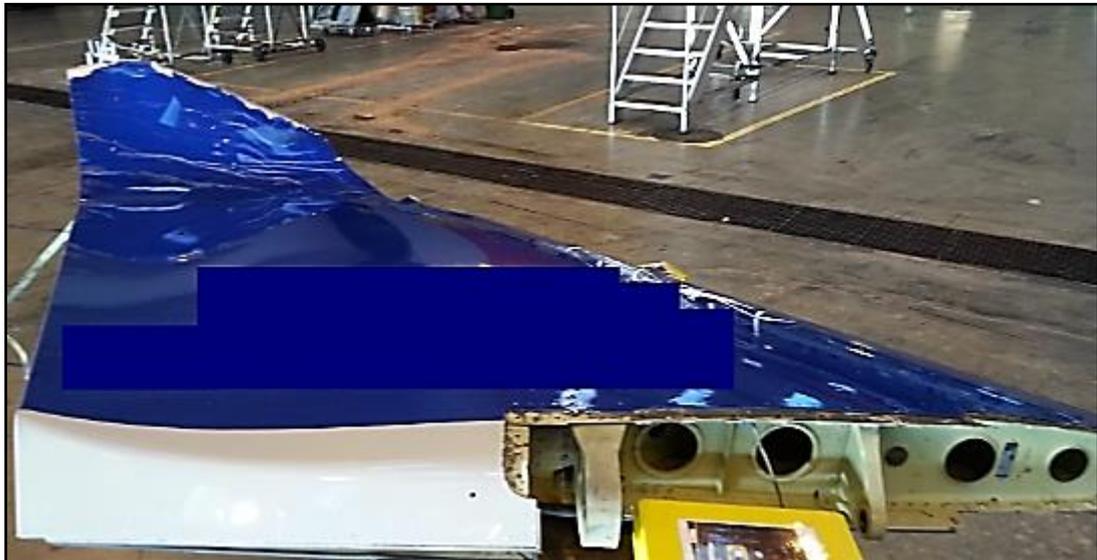
Picture 1

The right winglet of OY-KBC suffered minor damages

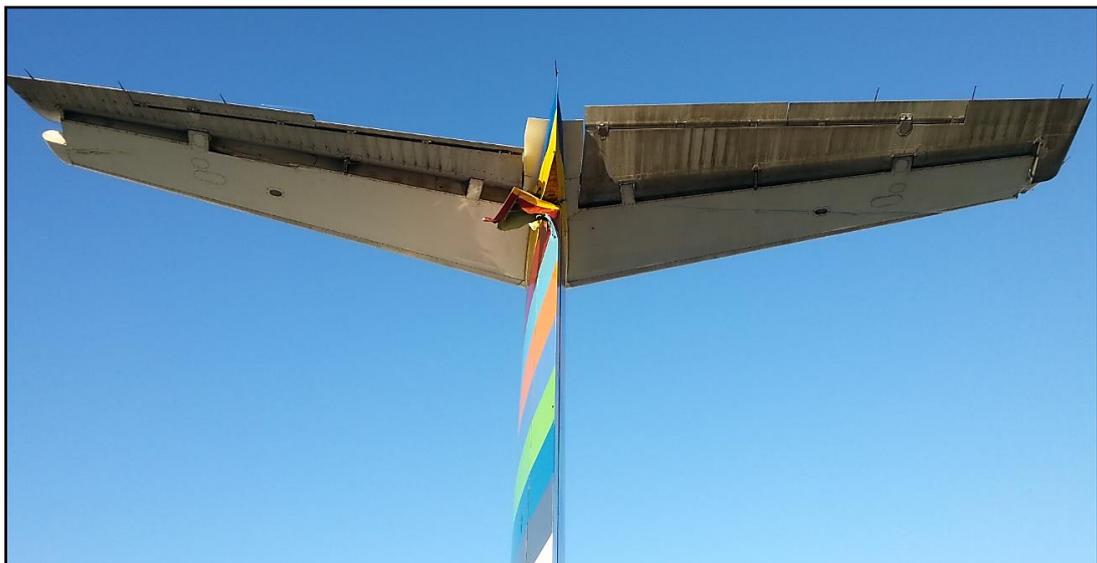
Picture 2

The horizontal stabilizer, the elevator and the rudder of SE-DST suffered substantial damages.

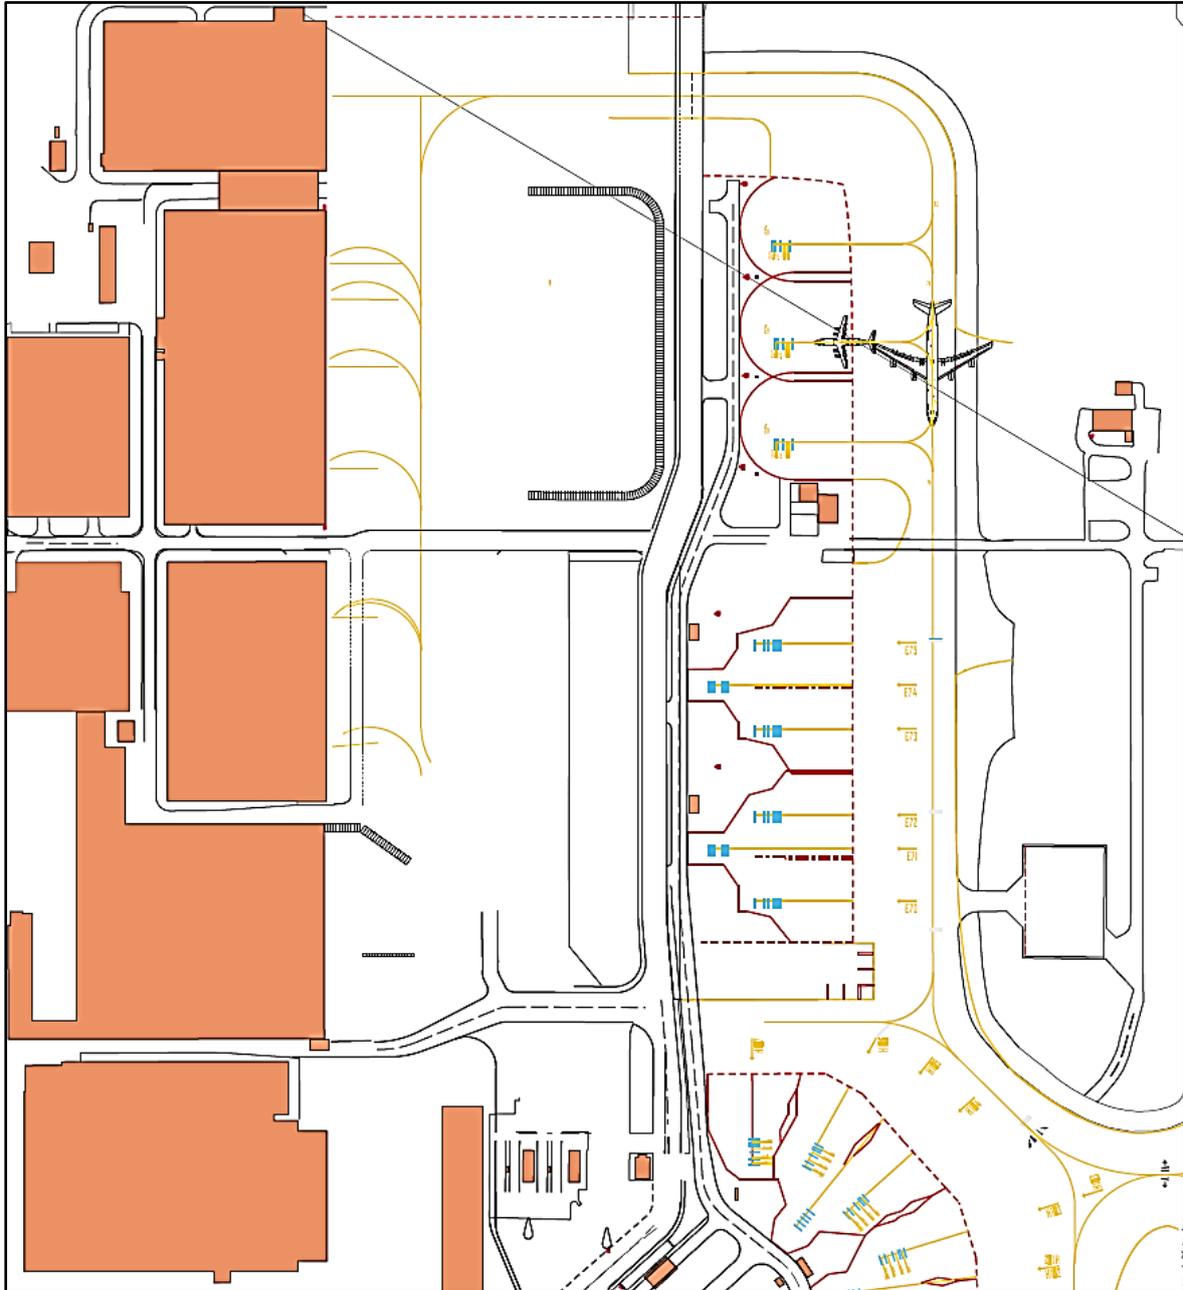
APPENDIX 6

A towbarless tractor (TBL) towed OY-KBC on taxiway T, and the winglet of OY-KBC collided with the tail section of SE-DST, which had not fully parked at aircraft stand E77.

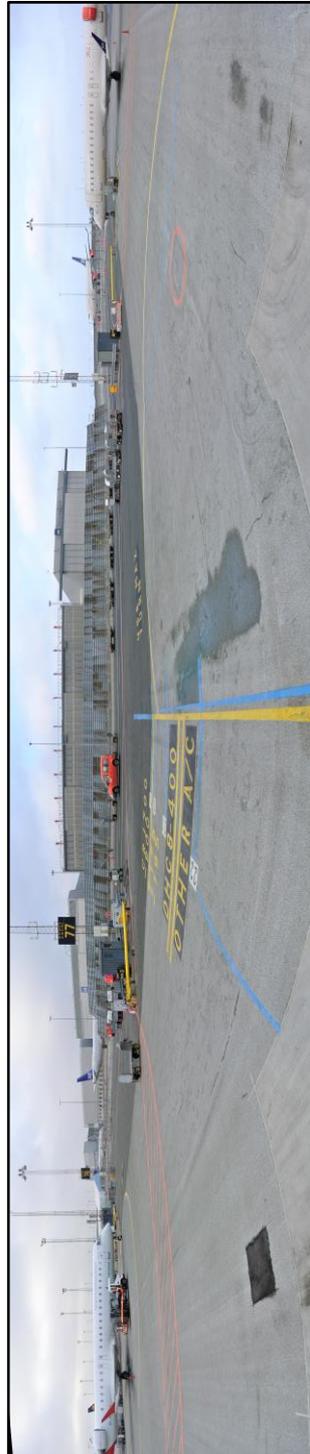
APPENDIX 7

When moving the aircraft onto aircraft stand E77, the flight crew of SE-DST stopped the aircraft approximately 14 metres in front of the aircraft stand stopping mark (“OTHER AIRCRAFT”).

The painted yellow markings on aircraft stand E77 were distinct.

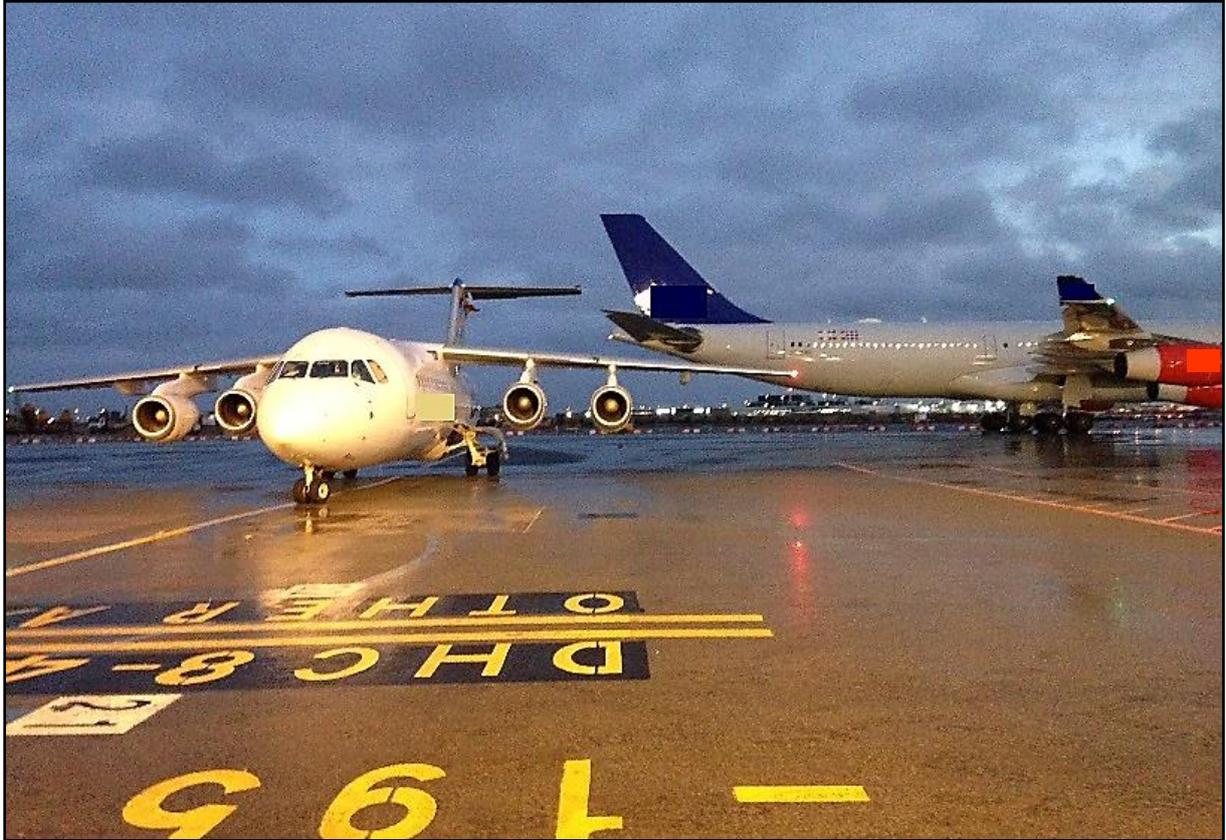
APPENDIX 8

At the time of the accident, the hangar area north and the aircraft stand E77 were fully illuminated.

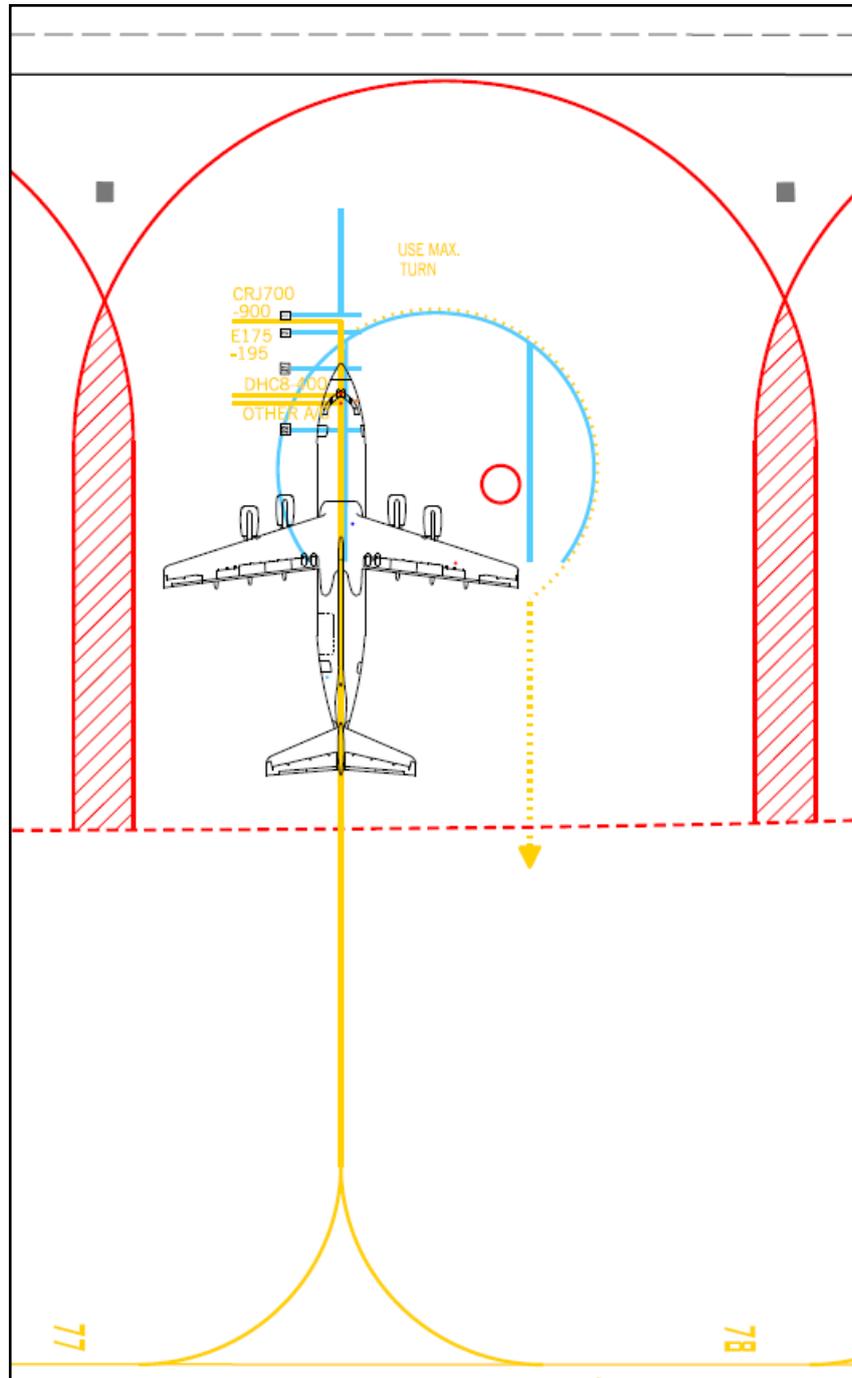
APPENDIX 9

The position of an Avro RJ100 optimum parked at aircraft stand E77 - [see appendix 9](#).

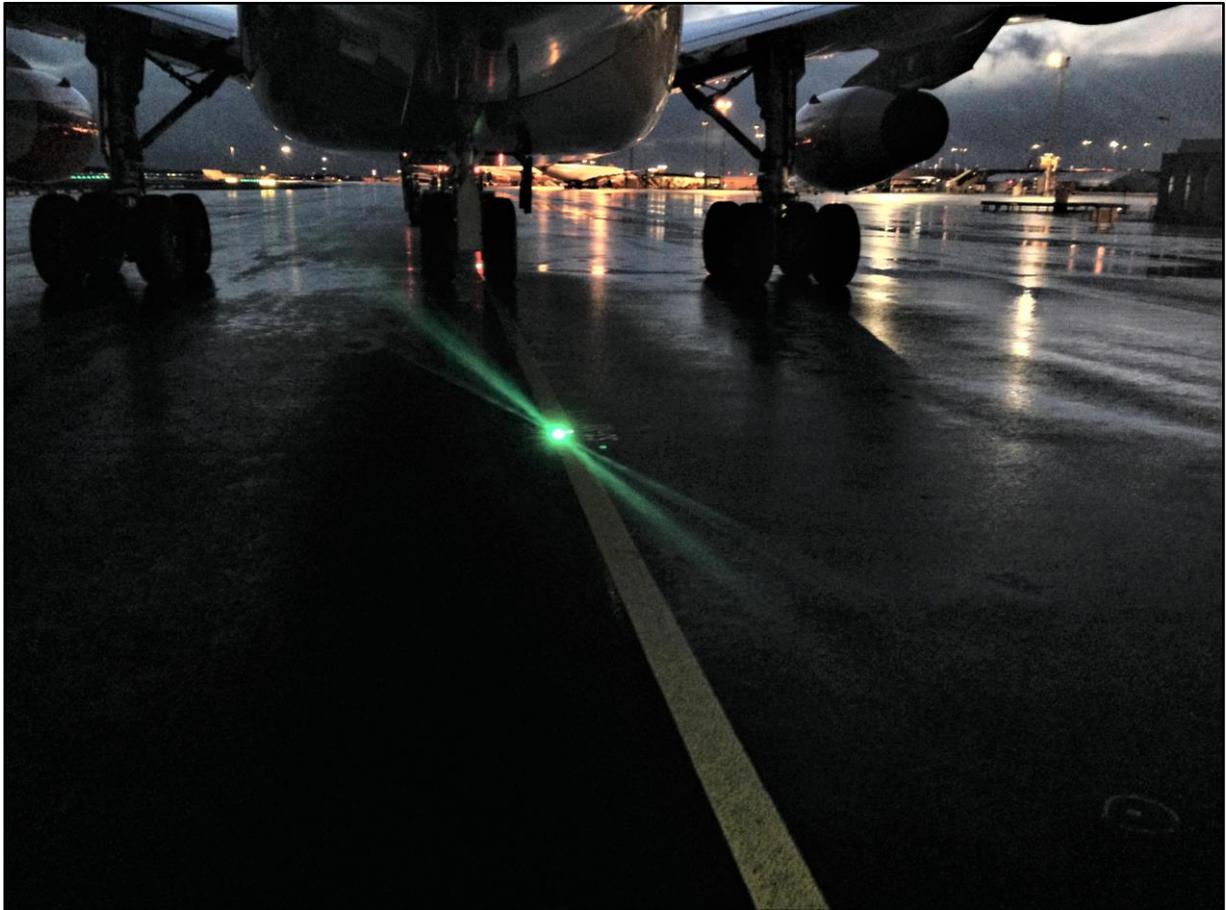
APPENDIX 10

The TBL towed OY-KBC on the green illuminated and distinctly yellow painted taxiway centerline.

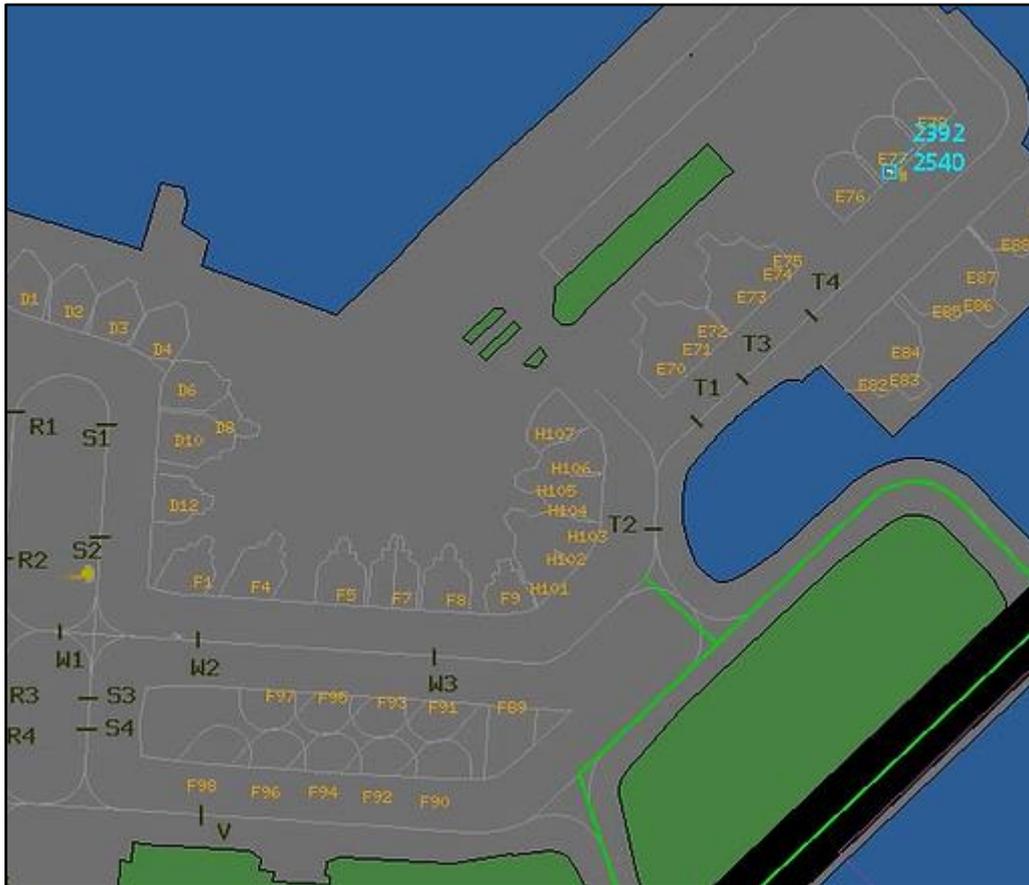
APPENDIX 11

At 15:07:02 hours, the white S-MGCS radar label (mode S radar information) of SE-DST changed colour from white to blue (primary radar information and in this particular case the assigned transponder code of SE-DST).

In the period between 15:06:56 hours and 15:07:50 hours, the S-MGCS radar label of SE-DST changed colour from white (mode S radar information) to blue (primary radar information). S-MGCS still presented the assigned transponder code of SE-DST.
