**Havarikommissionen**  
Accident Investigation Board Denmark

# **FINAL REPORT**

**6-6-2015**

**AVIONS ROBIN DR400**

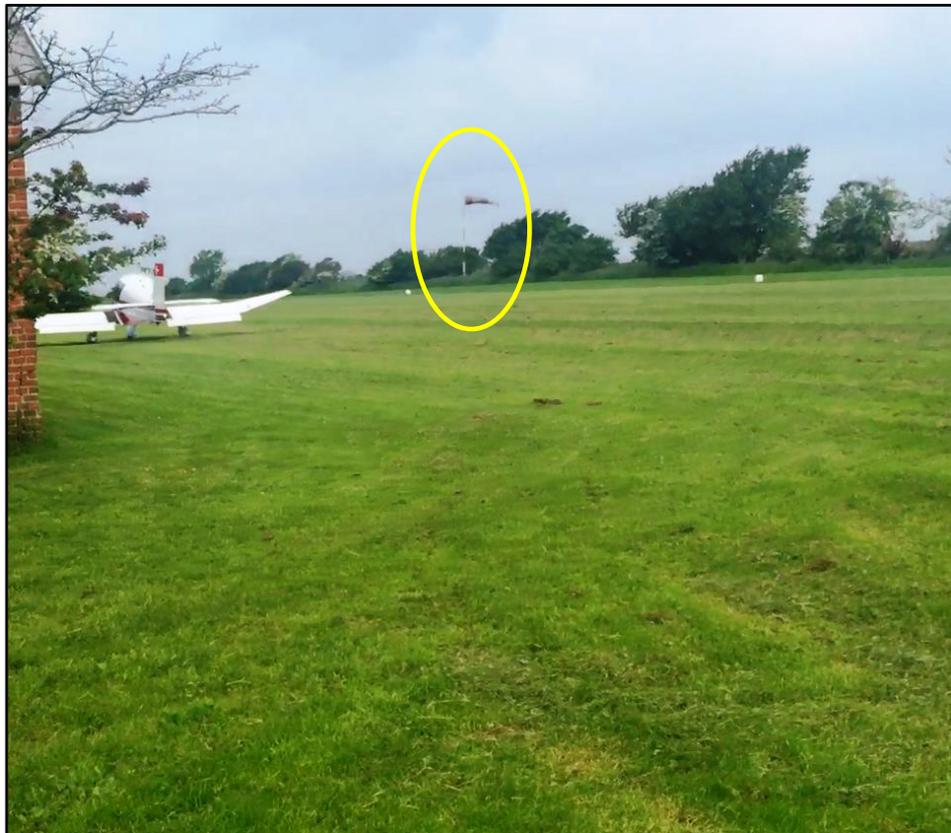
The picture below is taken just before the aircraft impacted with windbreak trees in front of the aircraft and along the runway side.

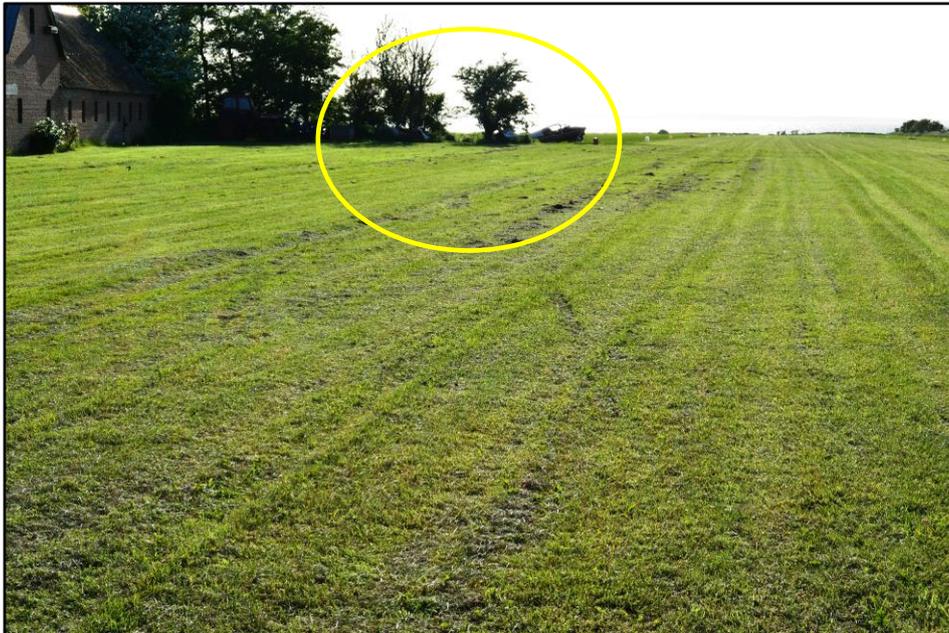
On an aircraft heading of approximately 280°, the aircraft rolled 97 meters until it impacted with windbreak trees and a parked runway roller (located 214 meters west of the threshold to runway 29) along the runway side.

Accident site - direction towards the West

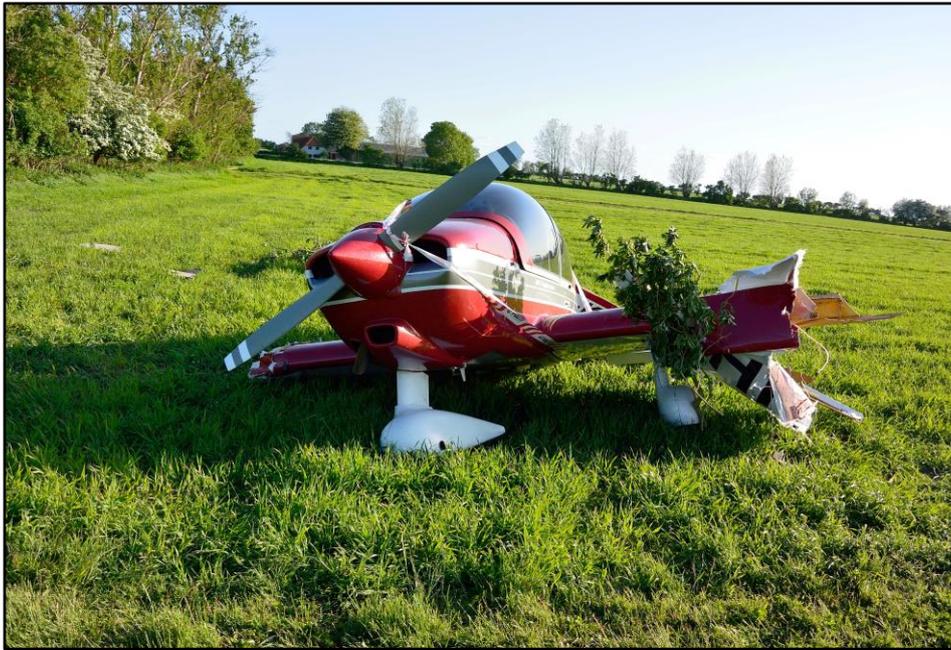
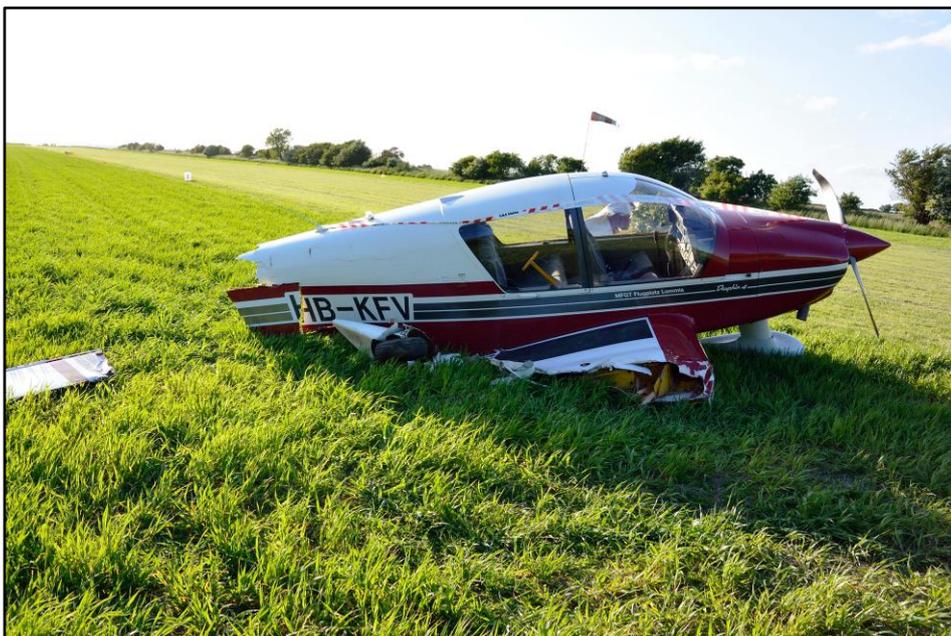
As a consequence of impacting with the windbreak trees along the runway side and a parked runway roller, the aircraft wings and tail section separated from the aircraft fuselage.

The forward part of the aircraft fuselage (cockpit) did not impact with the windbreak trees and the runway roller and remained intact.

The flaps at impact were in landing position (2<sup>nd</sup> notch).
