Havarikommissionen
Accident Investigation Board Denmark

FINAL REPORT

AVIONS ROBIN (DR 300/180R)

D-EJBB

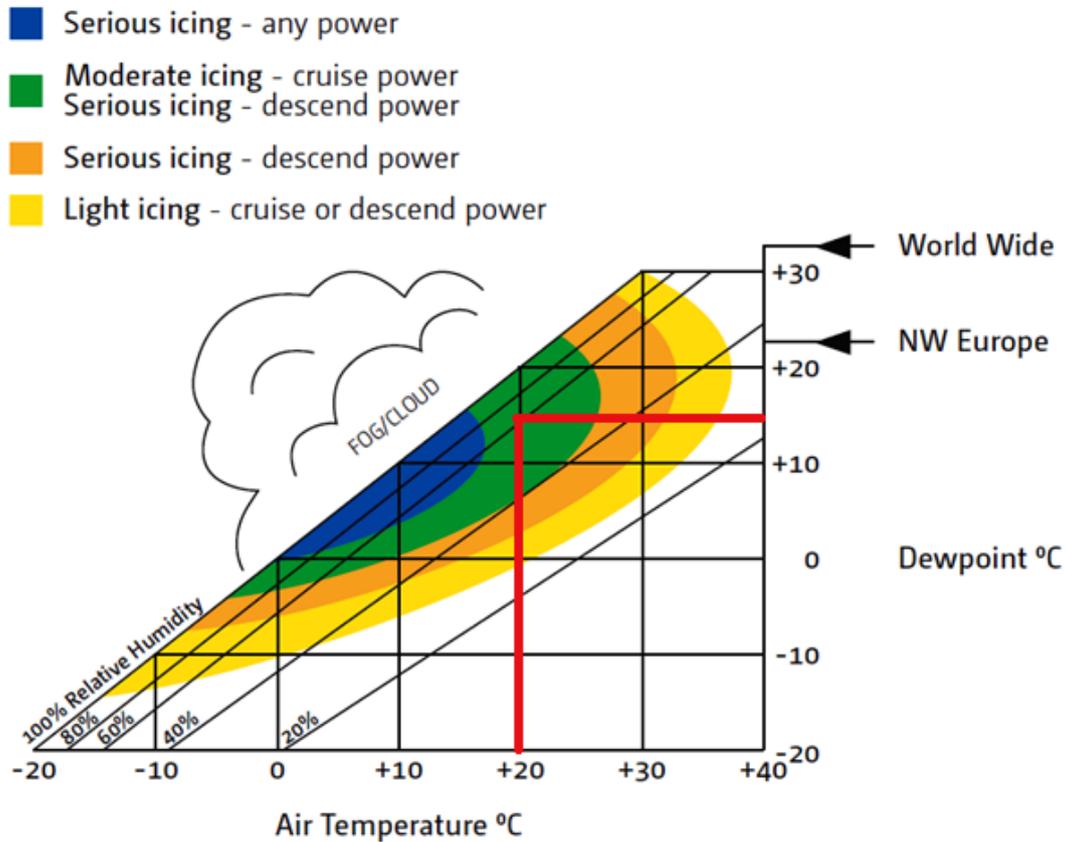
1.7.7 Risk of carburettor icing

The temperature and dewpoint lines in red refer to a weather observation (METAR) in EKOD at 10:50 hours.

6. The observed weather conditions in the area of Kerteminde were equivalent to the forecasted weather conditions
7. The risk of moderate carburettor icing at cruise power and serious carburettor icing at decent power was present

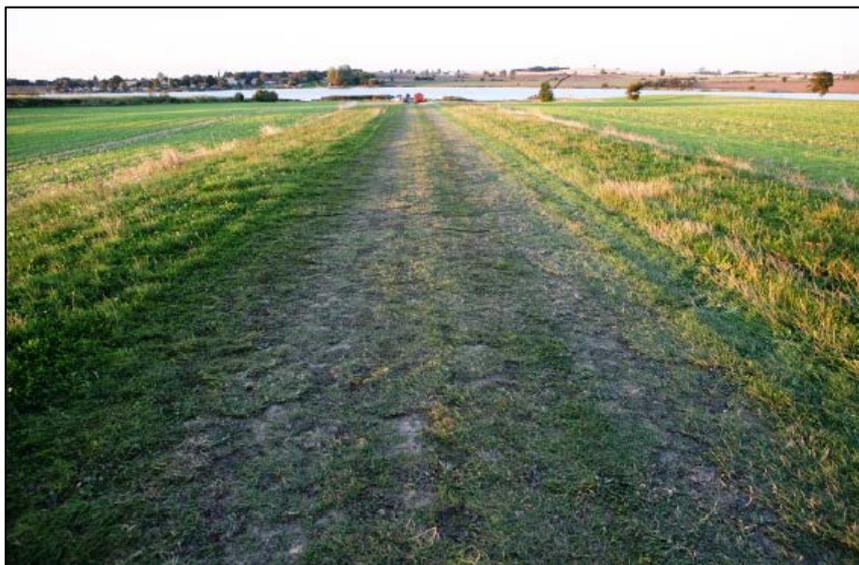
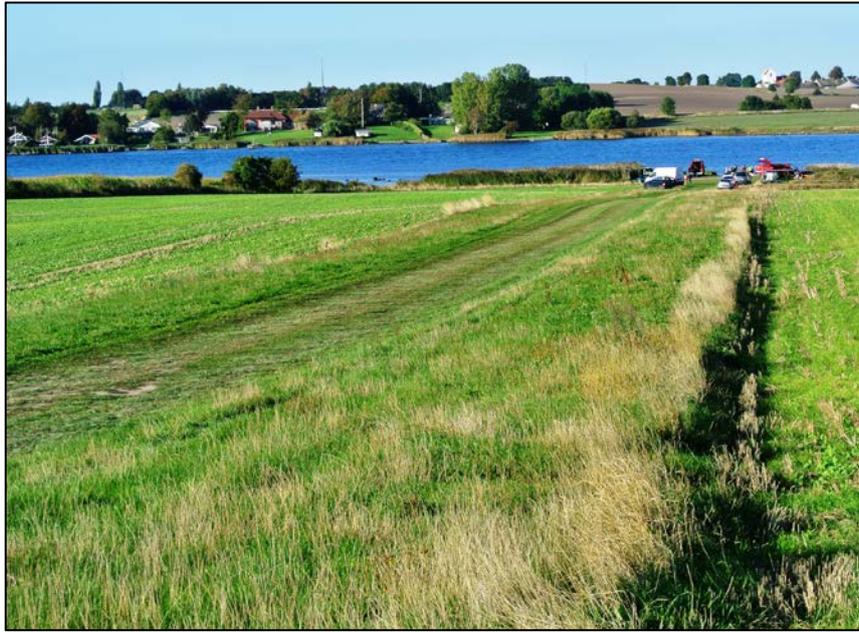
1.10.2 AIB observations and measurements

Runway 21 direction:	206° magnetic
Dimensions - surface:	428 x 4 meters - cut grass (trail). Outside the cut grass area, the length of the grass was approximately 7-10 centimetres
Runway slope:	Upslope (runway 21)
Runway conditions:	The following two pictures are taken in the direction from south towards north.

Furthermore, no airstrip wind information was available (worn windsock).

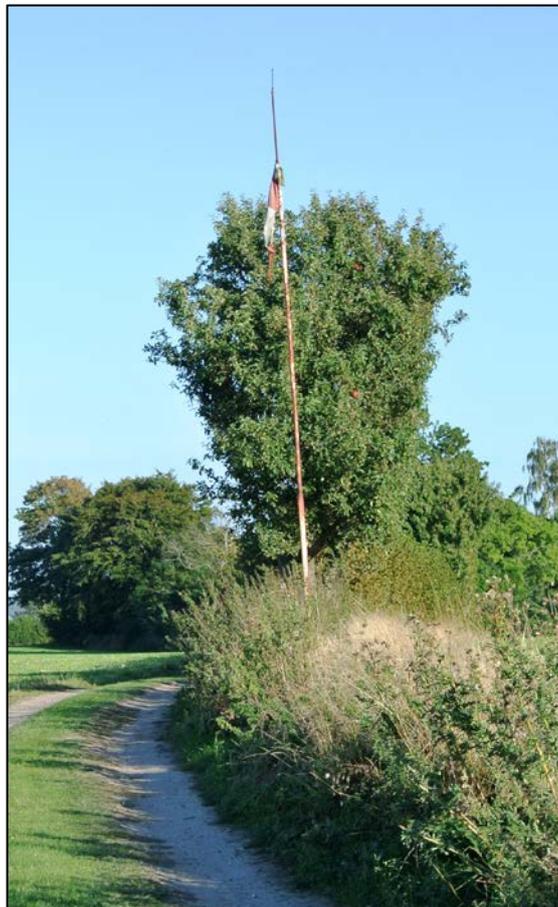
Windsock:

Placed next to and at the southern end of the airstrip

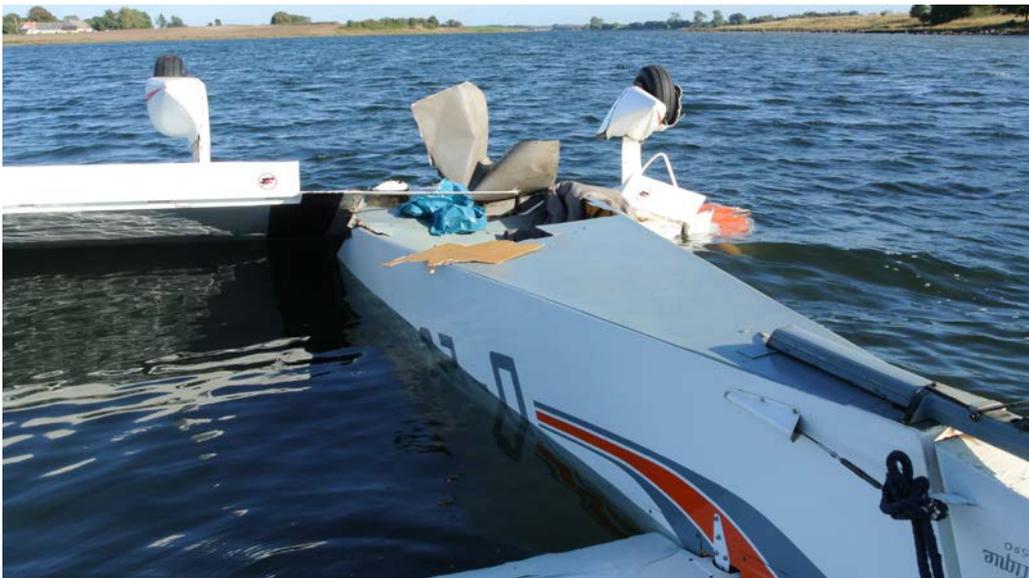
The left wing hit the water, separated from the fuselage and broke apart.

The engine separated from the fuselage and ended up on the floor of the fjord at a position approximately 50 meters northeast of the partly floating main fuselage.

Approximately 155 meters east of the threshold to runway 21 and 60 meters from the shoreline, the main fuselage ended up in an upside down position partly floating on the water.

The GPS position of the partly floating main fuselage was N55 27 17 E010 36 05.

The depth of water was approximately one and a half meters.
