Press release

Serious incident to CS-TNV (Airbus A320) in Copenhagen on 8-4-2022

Accident Investigation Board Denmark

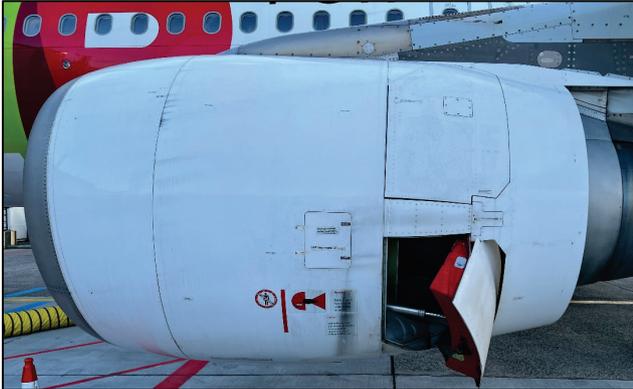
- No imprints of aircraft ground contact.
- No external damages to the aircraft (including aircraft fuselage, wings, tail and engine nacelles).
- Three out of four thrust reverser doors on engine no. 1 were in the fully deployed position.

Photo 1. Left side of engine no. 1.

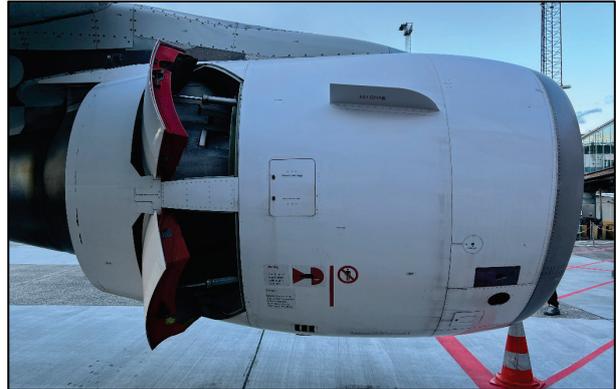
Photo 2. Right side of engine no. 1.
