STATEMENT

File number: HCLJ300-2017-75
UTC date: 30-9-2017
UTC time: 13:50
Occurrence class: Accident
Location: Overhead the southern part of Greenland
Injury level: None

Aircraft registration: F-HPJE
Make/model: AIRBUS A380-800-861
Current flight rules: Instrument Flight Rules (IFR)
Operation type: Commercial Air Transport Passenger Airline
Flight phase: En route
Aircraft category: Fixed Wing Aeroplane Large Aeroplane
Last departure point: France LFPG (CDG): Paris Charles-De-Gaulle
Planned destination: United States of America KLAX (LAX): Los Angeles Intl
Aircraft damage: Substantial
Engine type: Engine Alliance GP7270

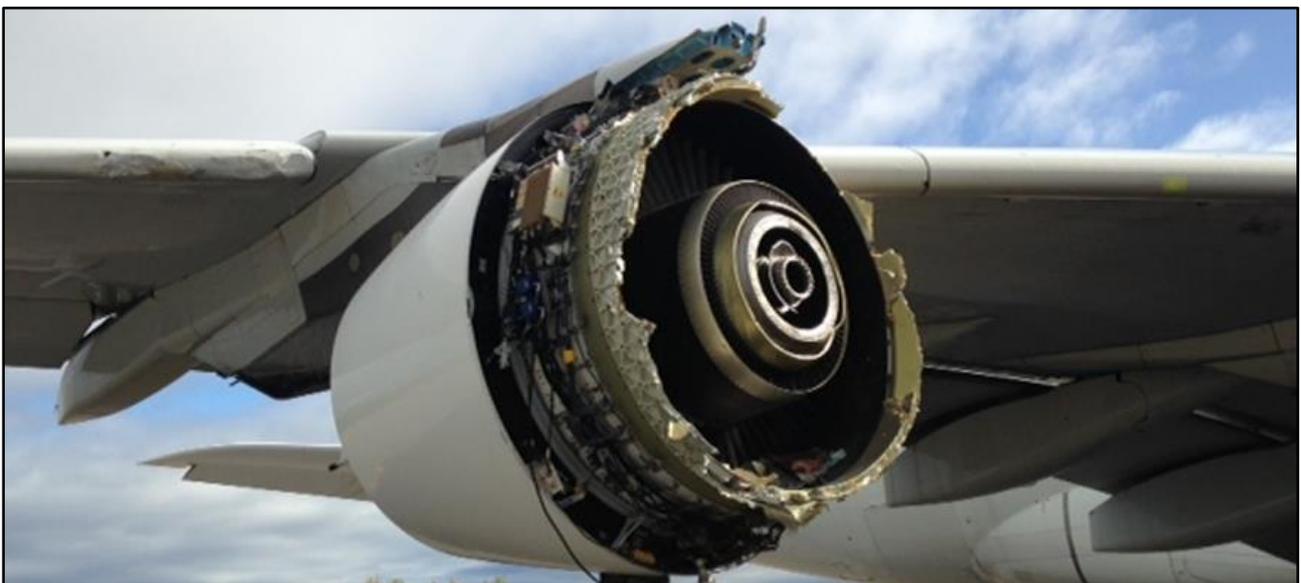
Damage to the aircraft seemed to be confined to engine number 4 and its immediate surroundings.

A visual inspection of the engine revealed that the fan, the rotating part at the front end of the engine, separated in flight, taking with it the whole air inlet cowling.
