Avoidable Accidents No. 1

# Low-level flying

Research  
AR-2009-041

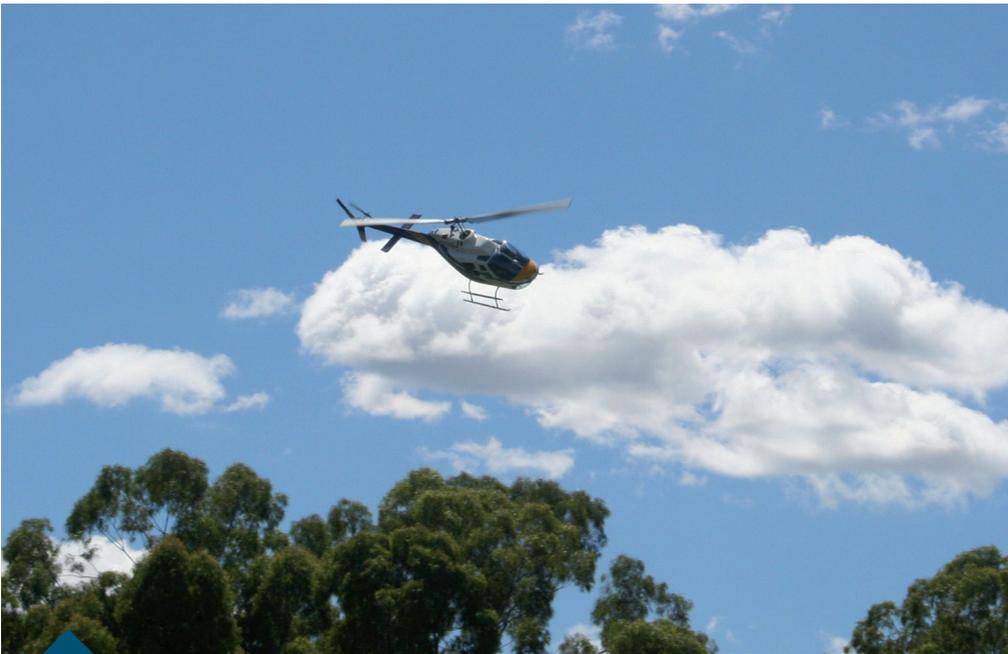
Witnesses reported that the helicopter was making low-level passes, about 100 ft above the ground, over the property. After one of the low passes, the helicopter banked steeply to the left, rolled out and descended. As the helicopter was being operated at a height at which recovery was not possible, it impacted surrounding trees. The helicopter was severely damaged and broke into several parts on impact.

The Bell 206B helicopter during a turn

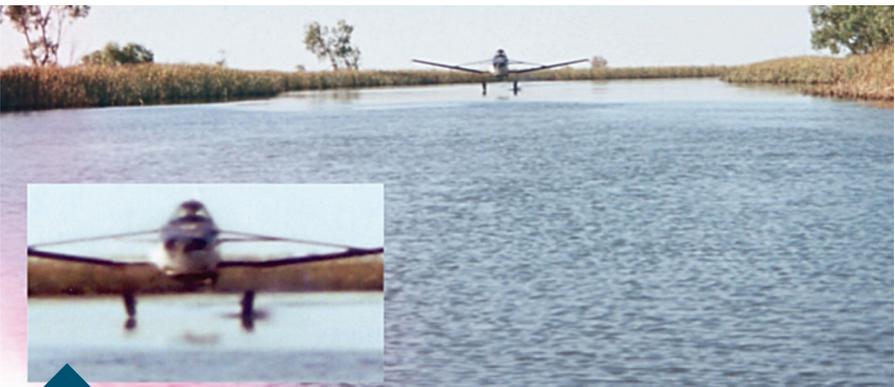
Although there were no witnesses to the accident itself, a number of people witnessed the pilot's flying activities prior to the accident. The pilot had landed in a paddock adjacent to a water-skiing area on a local river, where a large group of local people had gathered and a number of ski boats were operating. The pilot announced an intention to do some low passes over the water-ski area. Before taking off for those low passes, the pilot handed his camera to a friend (also a pilot) so he could take pictures of him flying over the water-ski site. After making four very low passes, the pilot landed in the paddock and retrieved his camera. One of the recovered camera images showed the aircraft's main wheel touching the surface of the water during at least one of the low passes.

Images from the pilot's camera of the day's flying activities

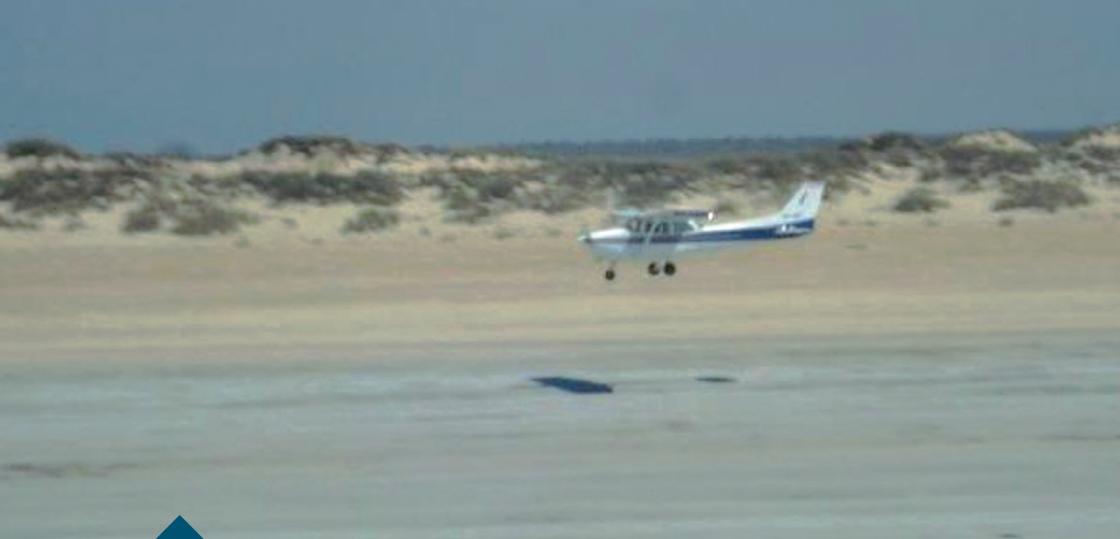
Earlier low flying by the group of tourists
